Planning Advisory Group Presentation – Chapter 330 Summary

Rebuild Plan – Chapter 330

Northern Maine Transmission System

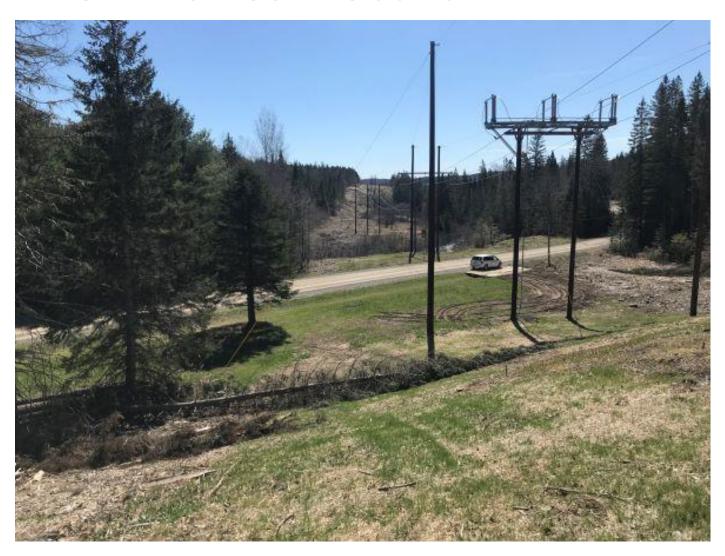
Line 1176 Post Rebuild

Structure rebuilt with an in-line switch for sectionalizing, ROW widened, lightning protection installed.

Notice the fir tree that fell from outside of the cleared ROW with no affect

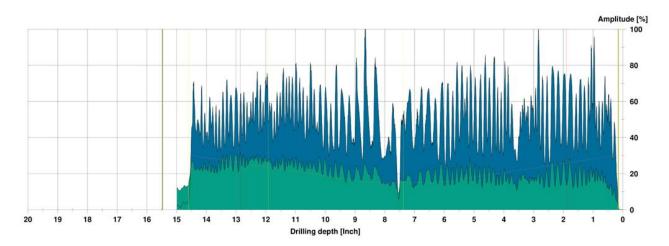
20694M047 (PASS).rgp

Resistograph Plot - Wood Pole in good condition

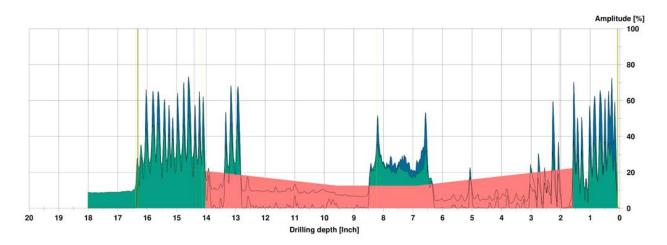
20781M013 (REJECT).rgp

Rejected Wood Pole – Heart Rot

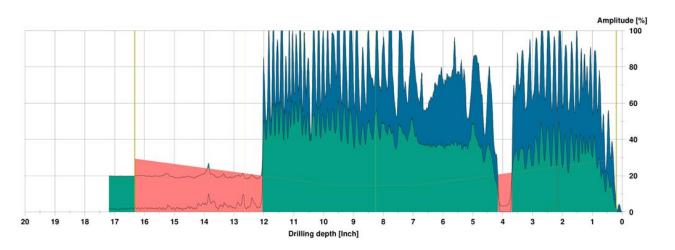
20705M046 (REJECT).rgp

Rejected Wood Pole – Heart Rot & Shell Rot

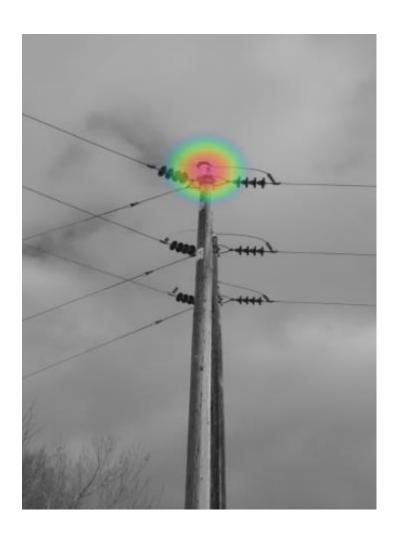
This is classified as a surface or internal discharge. The discharge appears to be strong and might rapidly escalate to complete insulation breakdown.

Immediate action. Visual inspection. Cleaning of polluted surfaces. Repair or replacement of the components.
