June 24, 2024

# 2024 Chapter 330 Report

# Northern Maine Transmission System Chapter 330 Work Plan Map

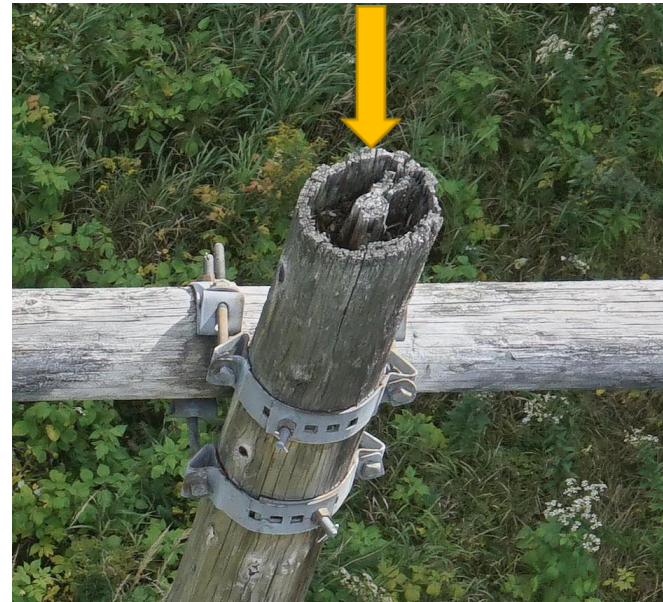
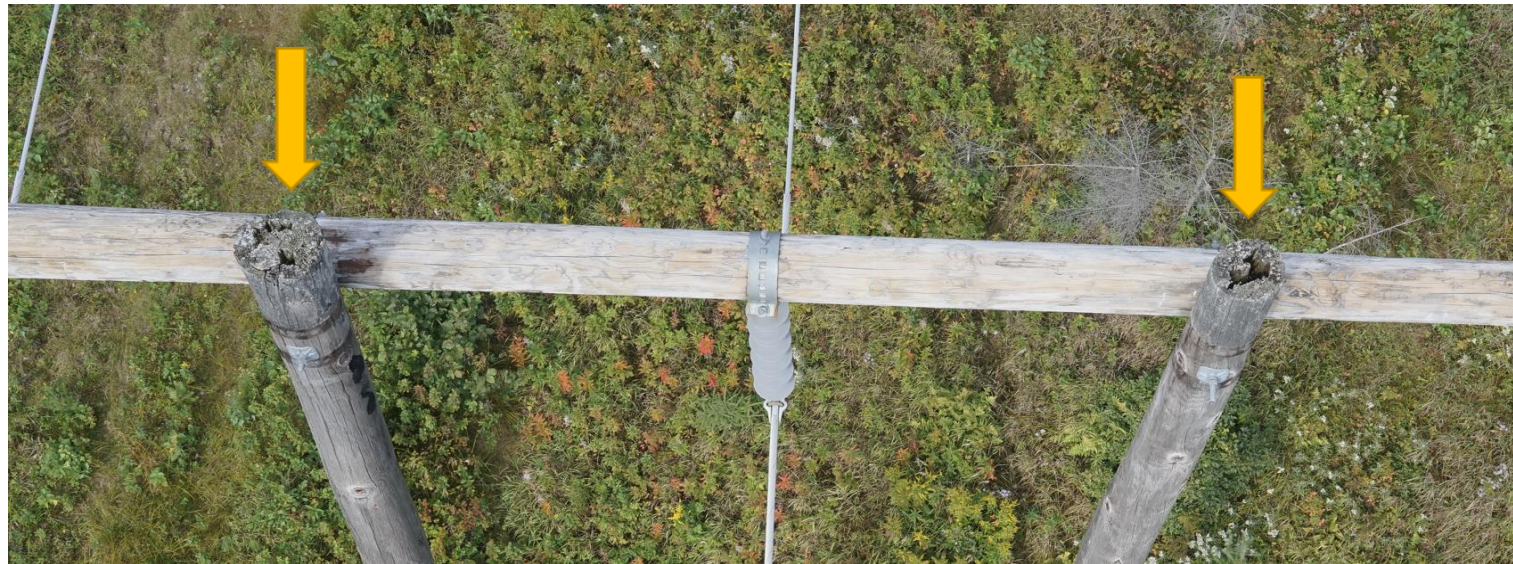
# Line 6905 Condition

Wood pole top rot

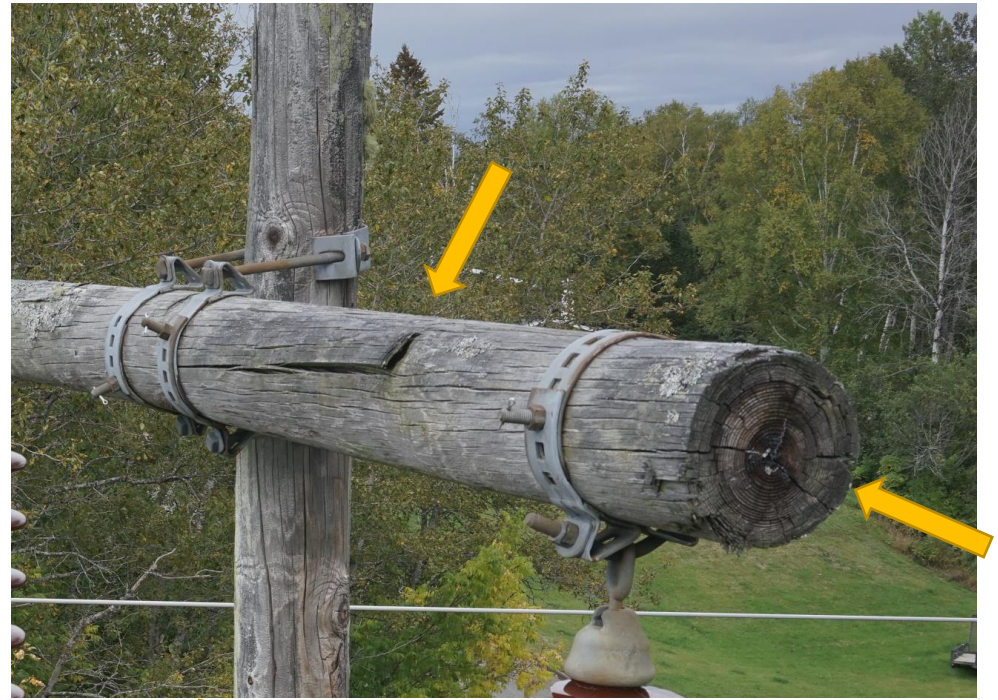
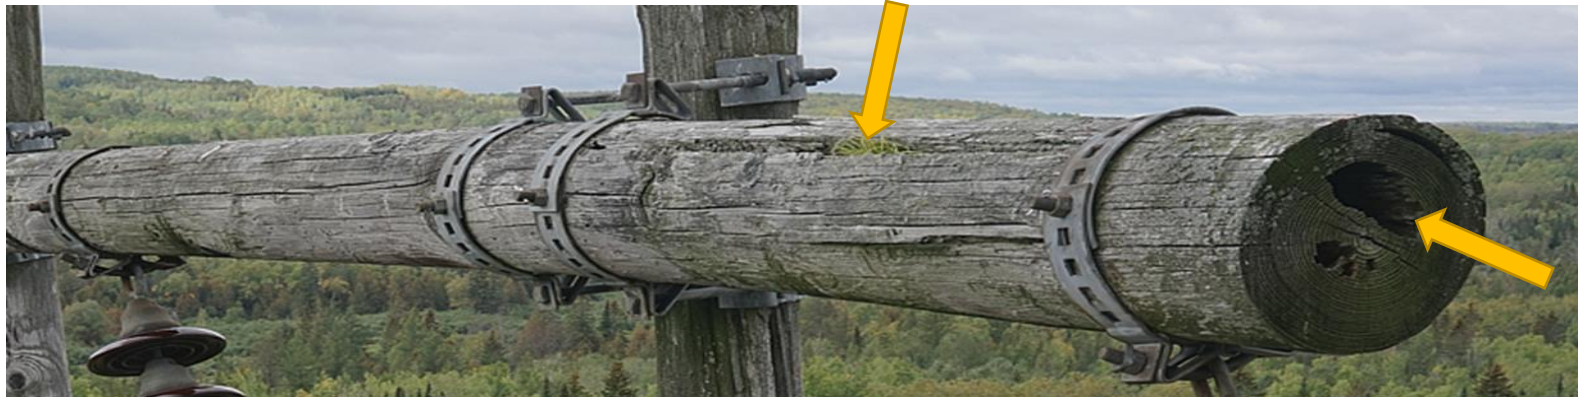
# Line 6905 Condition continued...

**Drooping  
crossarm under  
weigh of  
conductors likely  
caused by  
internal decay**

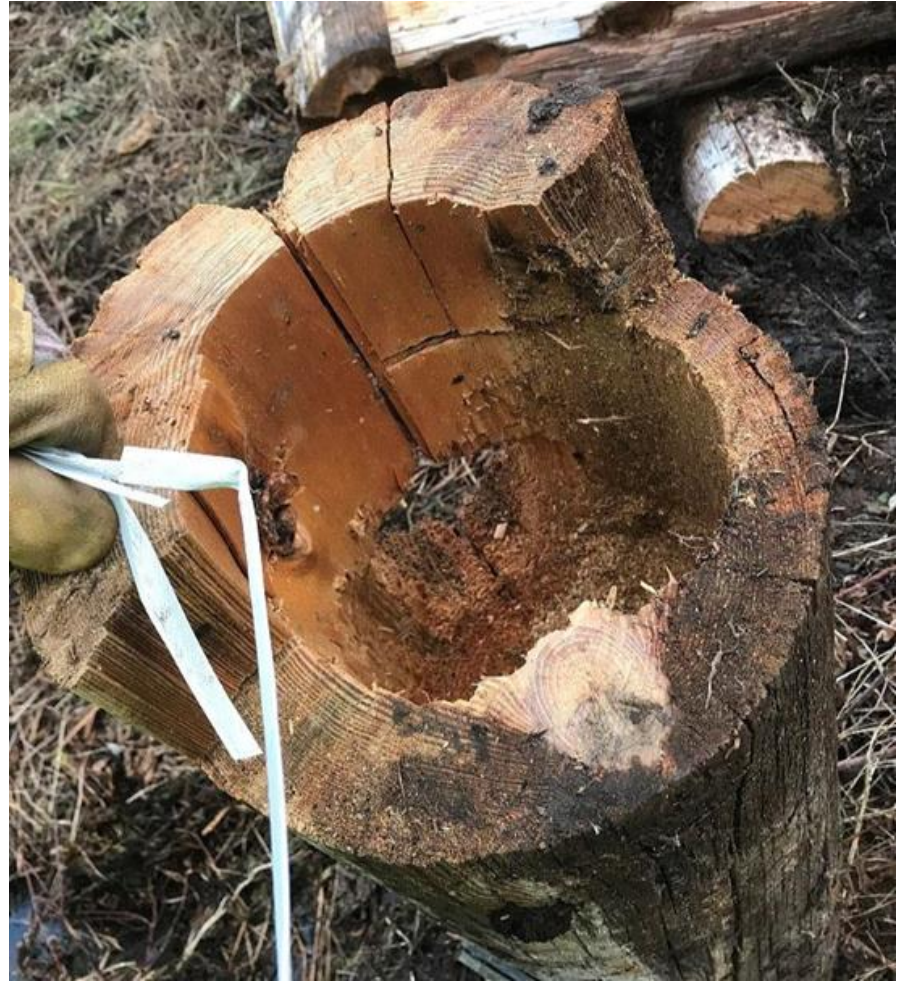
# Line 6905 Condition continued...

- **Line 6905 – Line connects Madawaska Substation to Limestone Substation serving Grand Isle and Van Buren communities via tap lines. Constructed in 1964, the wood poles and wood pole crossarms are aging and weakening - rejects are increasing significantly. Phased rebuild of this line planned to begin in 2024 and to continue through 2030.**

**Company inspectors are finding increased heart rot decay in wood poles reaching end of life, leading to structure replacements**

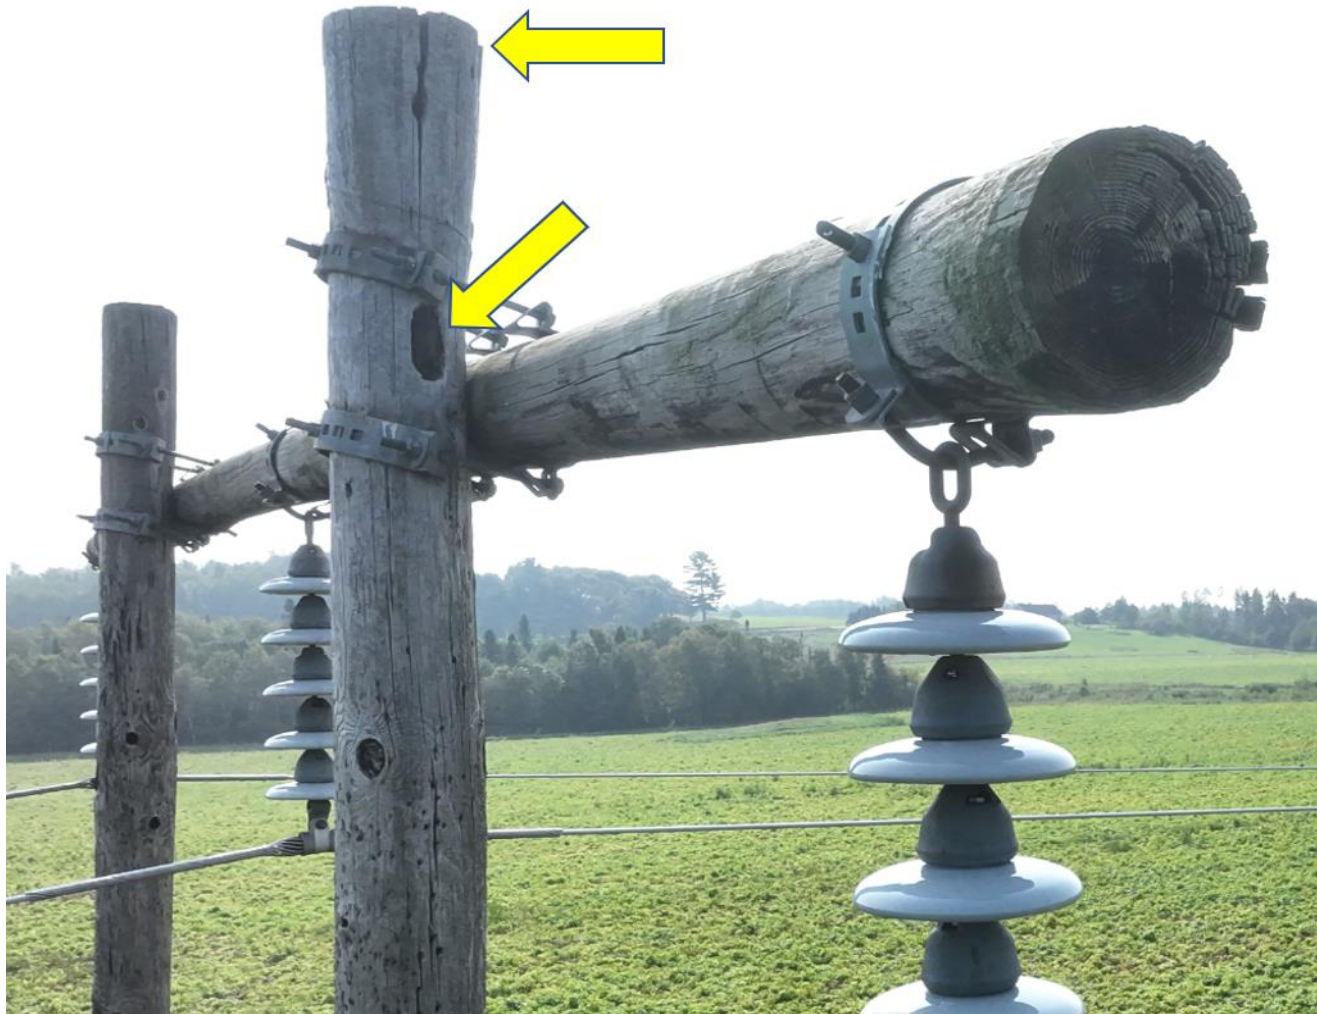
# Line 6930 Condition

- **Line 6930 – Line connects Caribou Substation to Ashland Substation with a tap serving the Washburn community. The line is 34 miles long, with 133 structures, 20% of structures have been replaced. The most recent drone inspection indicates 9 rejected poles, 94 have moderate decay, 24 low decay. TRPI in 2024 to replace 24 poles. Further TRPI work is likely in the near future.**

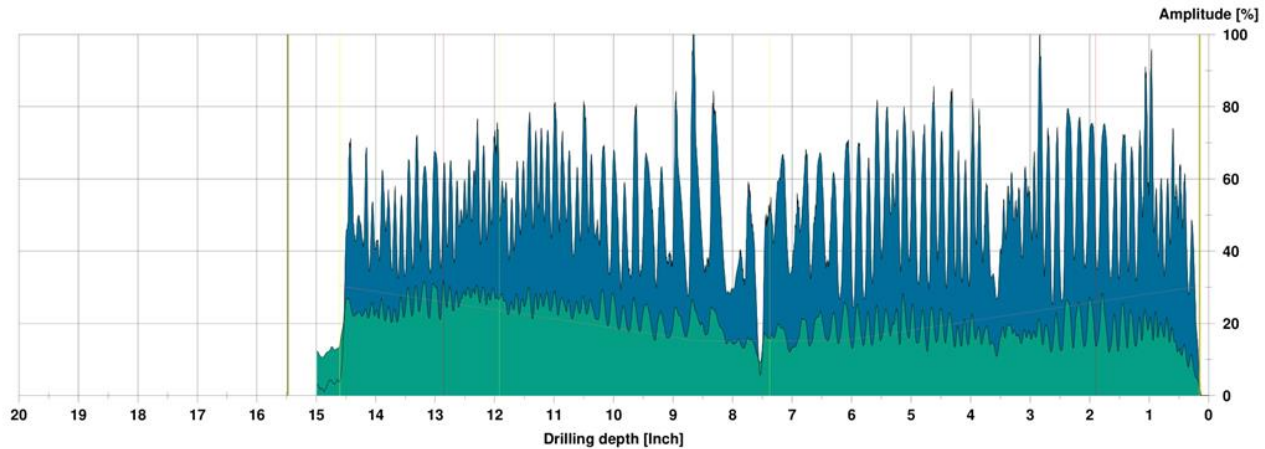
# Resistograph Plot - Wood Pole in good condition

Program	: Pole - EMERA 1.00	Sum decay	: 0,0%   0,0%   0,0%
Pole type	:	Heart rot	: 0,0%   0,0%   0,0%
Measurement	: Below soil level	Shell rot	: No   No
Defect pattern	: No decay	Remaining wall	: 50,0%   50,0%   50,0%
Result (auto)	: PASS	Strength	: 100,0%   100,0%   100,0%

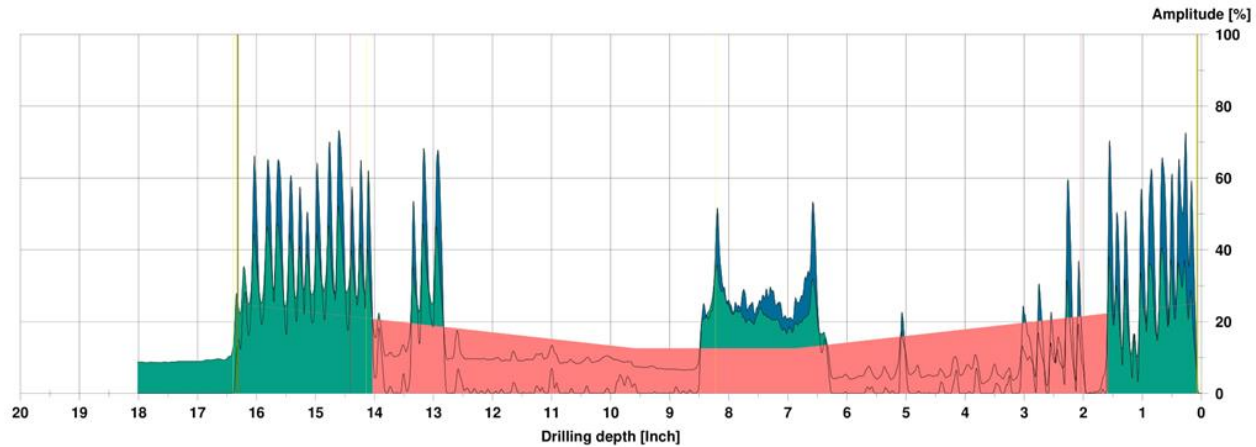
# Rejected Wood Pole – Heart Rot

Program :	Pole - EMERA 1.00	Sum decay :	40,7%	35,6%	76,3%
Pole type :		Heart rot :	40,7%	35,6%	76,3%
Measurement :	Auto diameter	Shell rot :	No	No	
Defect pattern:	Heart rot	Remaining wall:	9,3%	14,4%	11,8%
Result (auto) :	REJECT	Strength :	56,1%	74,3%	65,2%

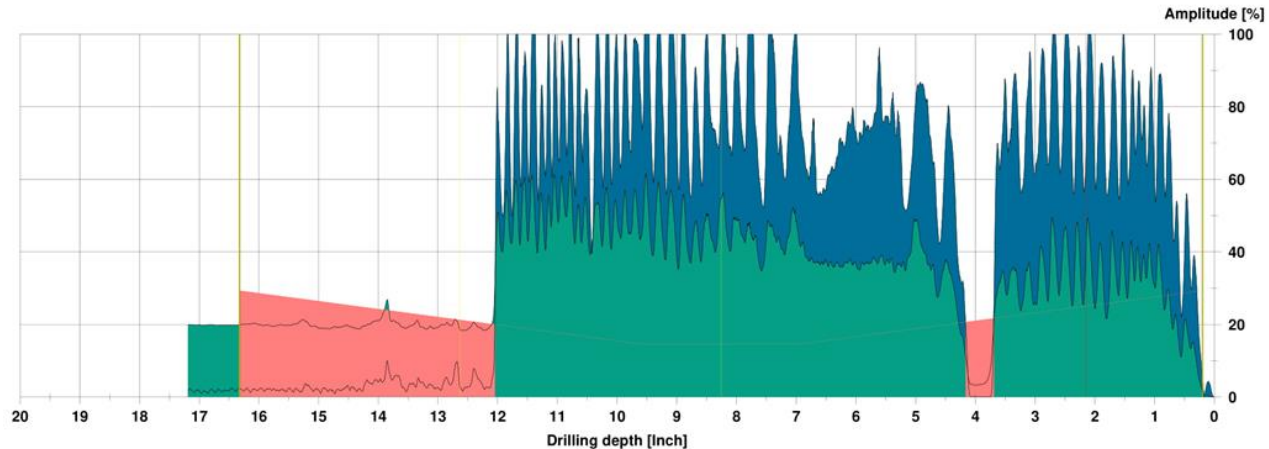
# Rejected Wood Pole – Heart Rot & Shell Rot

Program :	Pole - EMERA 1.00	Sum decay :	2,9%	0,0%	2,9%
Pole type :		Heart rot :	2,9%	0,0%	2,9%
Measurement :	Below soil level	Shell rot :	No	Yes	
Defect pattern:	Heart+shell rot	Remaining wall:	21,7%	---	
Result (auto) :	REJECT	Strength :	89,7%	---

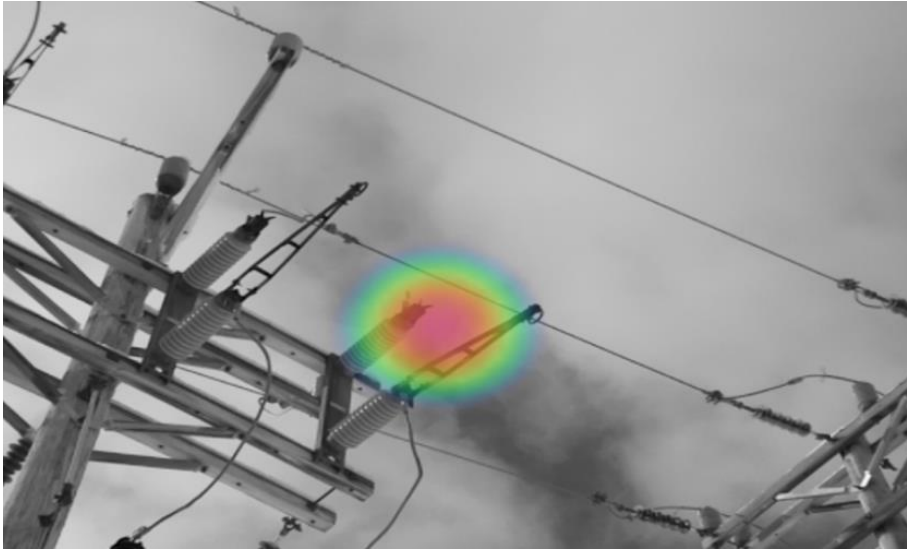
This is classified as corona, i.e., partial discharge into air. In most cases, corona is harmless.

Typically no action required unless power loss, audible noise, electromagnetic interference, or deterioration of nearby polymer insulators is a problem.

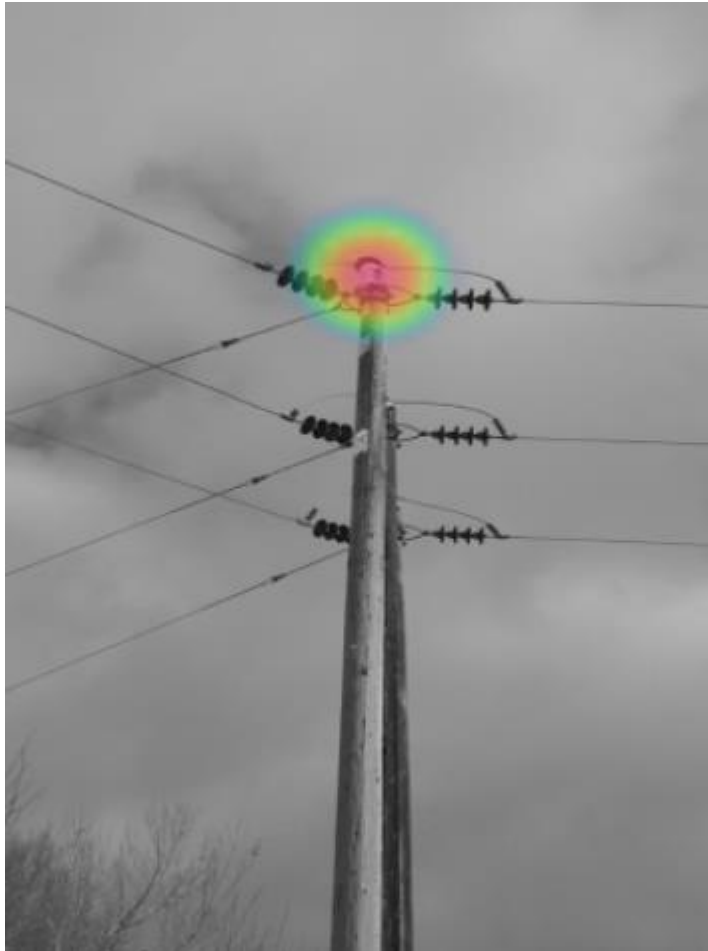
This is classified as a surface or internal discharge. The discharge appears to be strong and might rapidly escalate to complete insulation breakdown.

Immediate action. Visual inspection. Cleaning of polluted surfaces. Repair or replacement of the components.
