JUNE 20, 2019

**Northern Maine
Planning Advisory Group
Meeting**

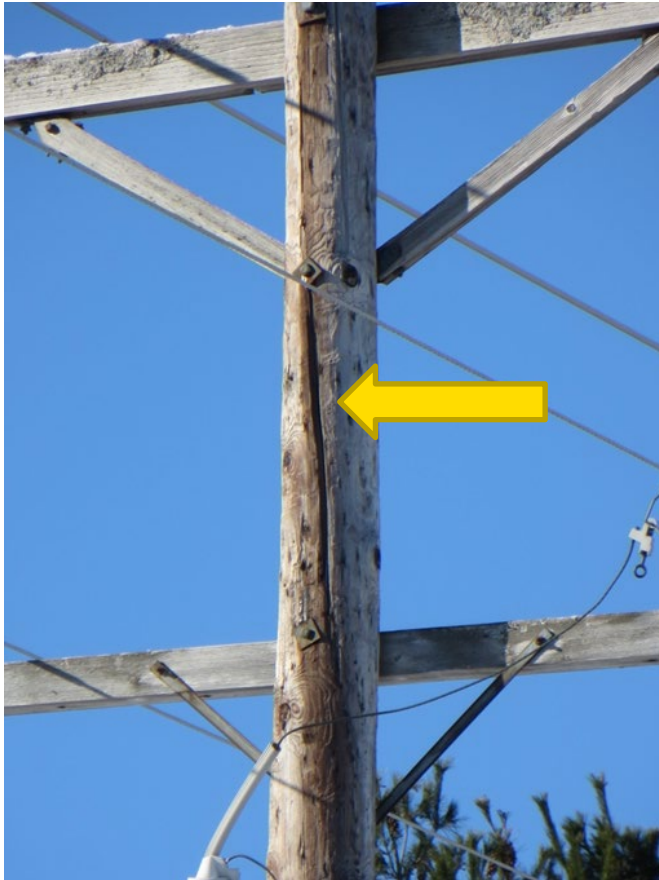
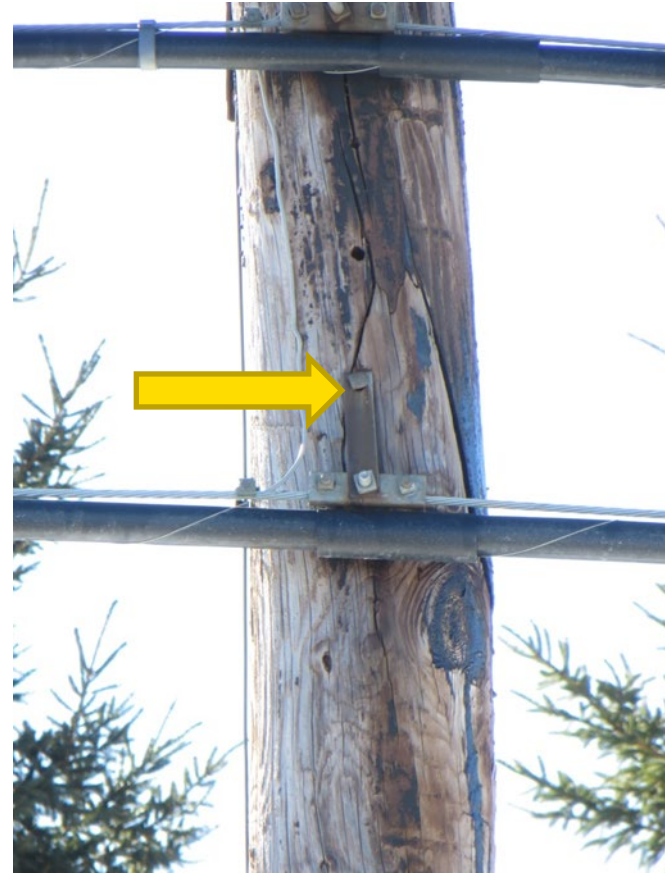
Line 6913 Rebuild (Mapleton)

Cracked roadside transmission poles with distribution circuit 12-22 underneath

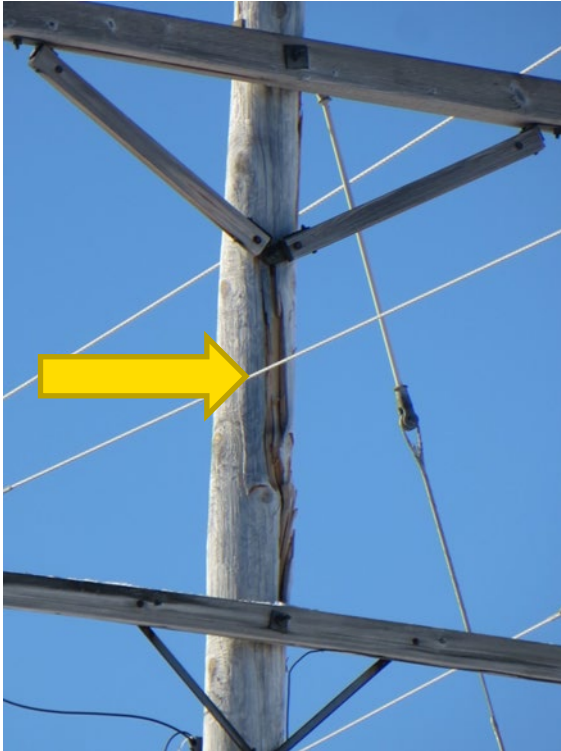
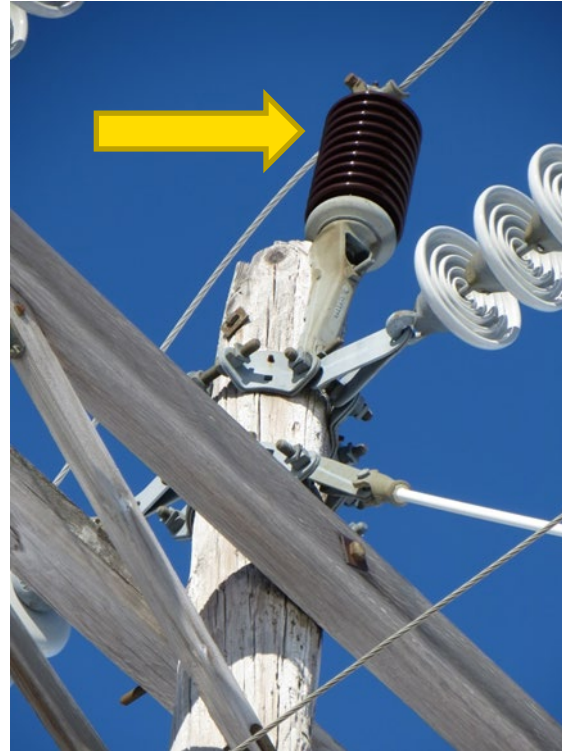
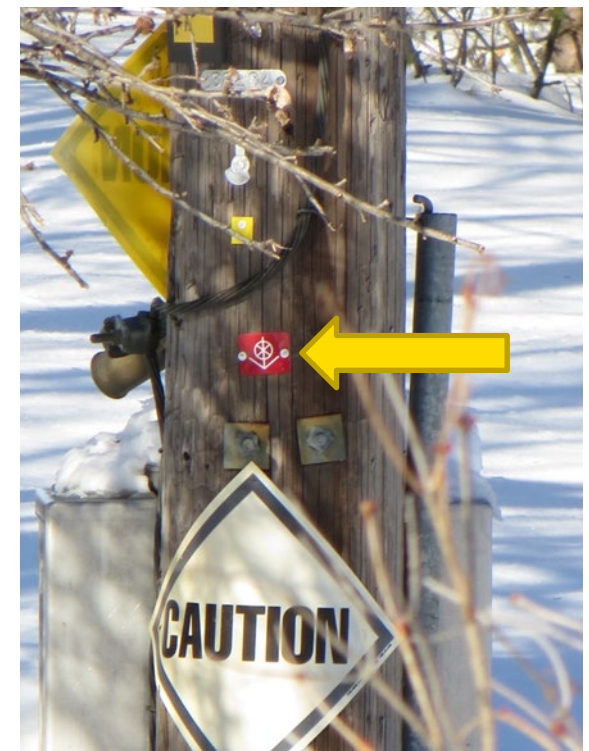
Line 6913 continued...

Lightning damaged pole, brown glass post type insulator and rejected wood pole due to internal rot

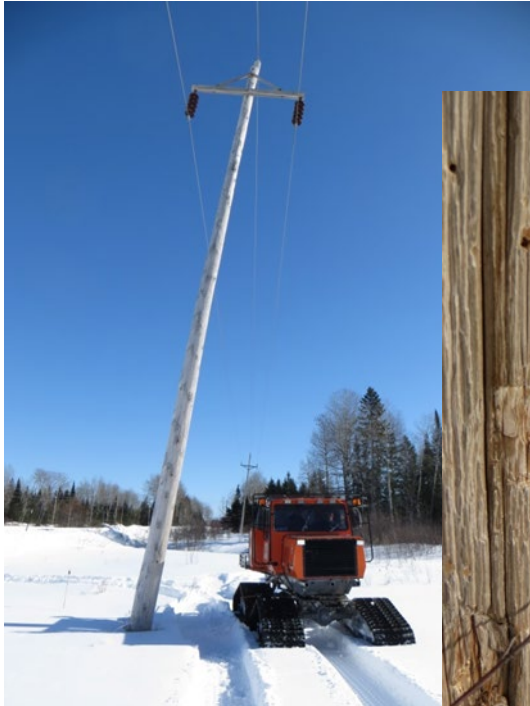
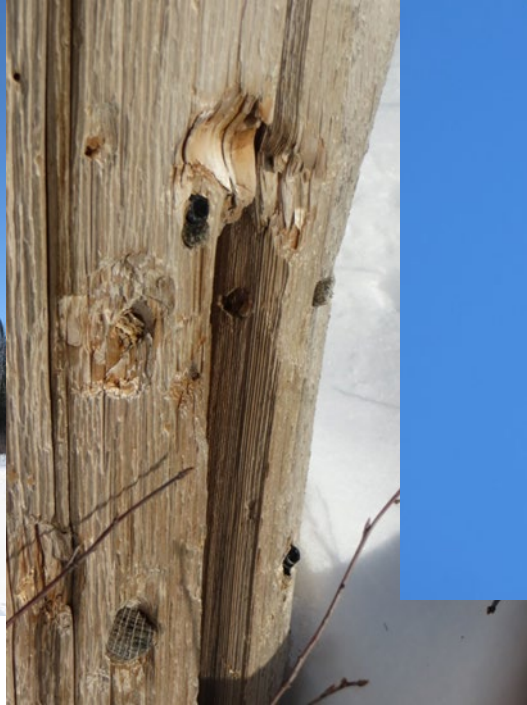
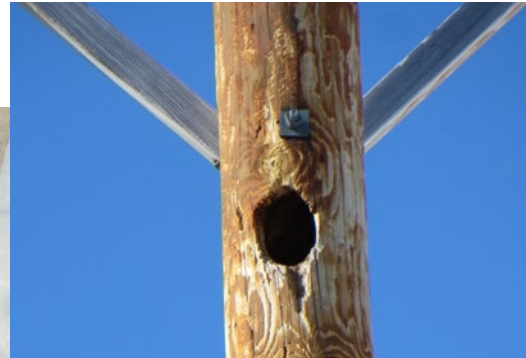
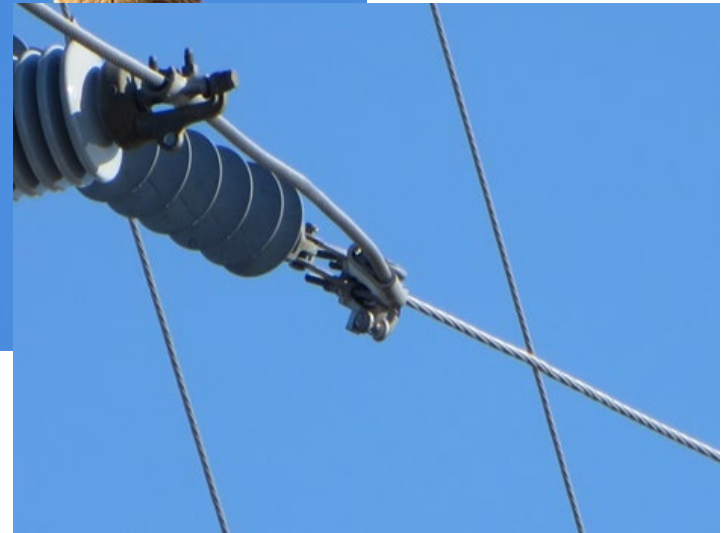
Line 6913 continued...

Rotting pole base resulting in a leaning pole, other poles with cracked base and woodpecker damage, small 3/0 ACSR conductor

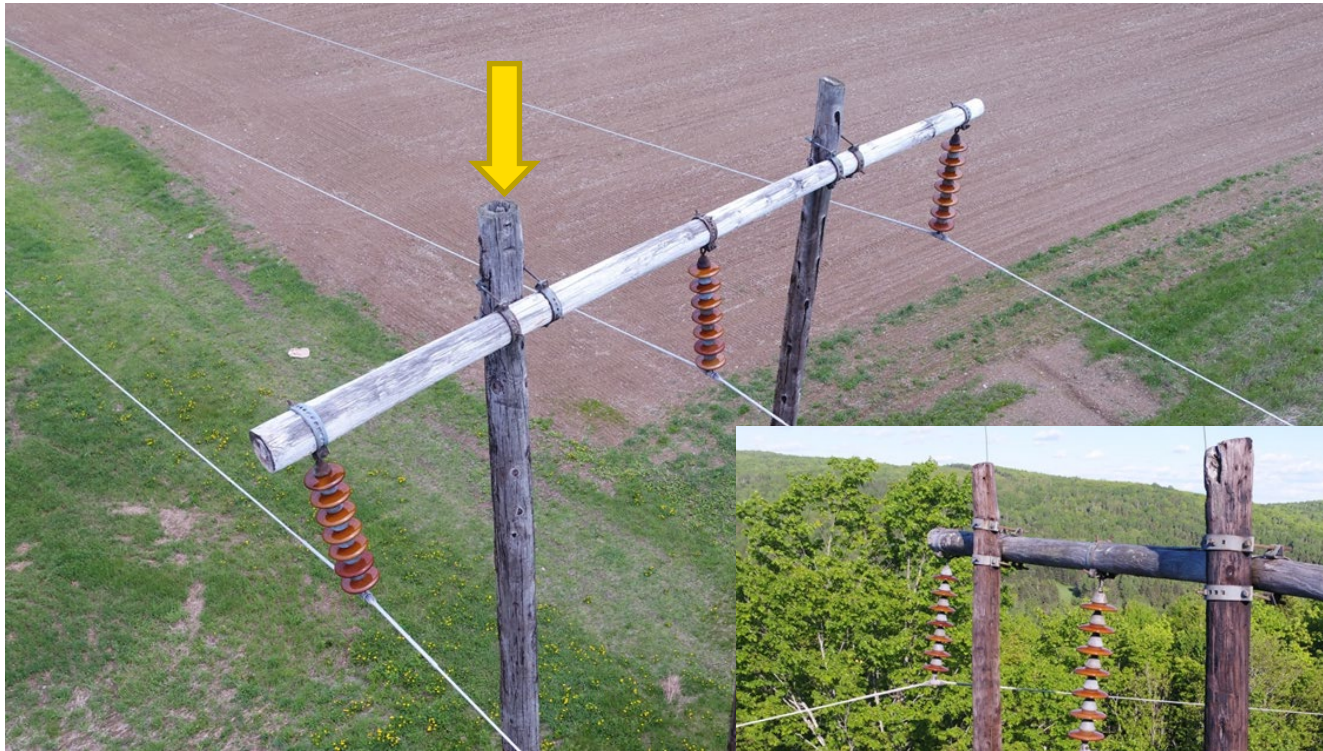
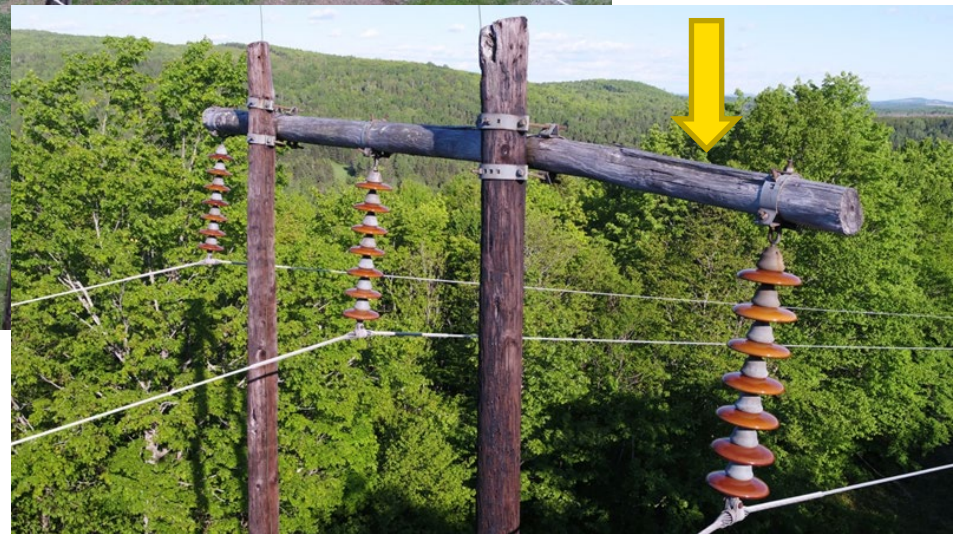
Line 1176 Rebuild per Inspection

Hollow pole top and crossarm with extreme decay identified by drone inspection

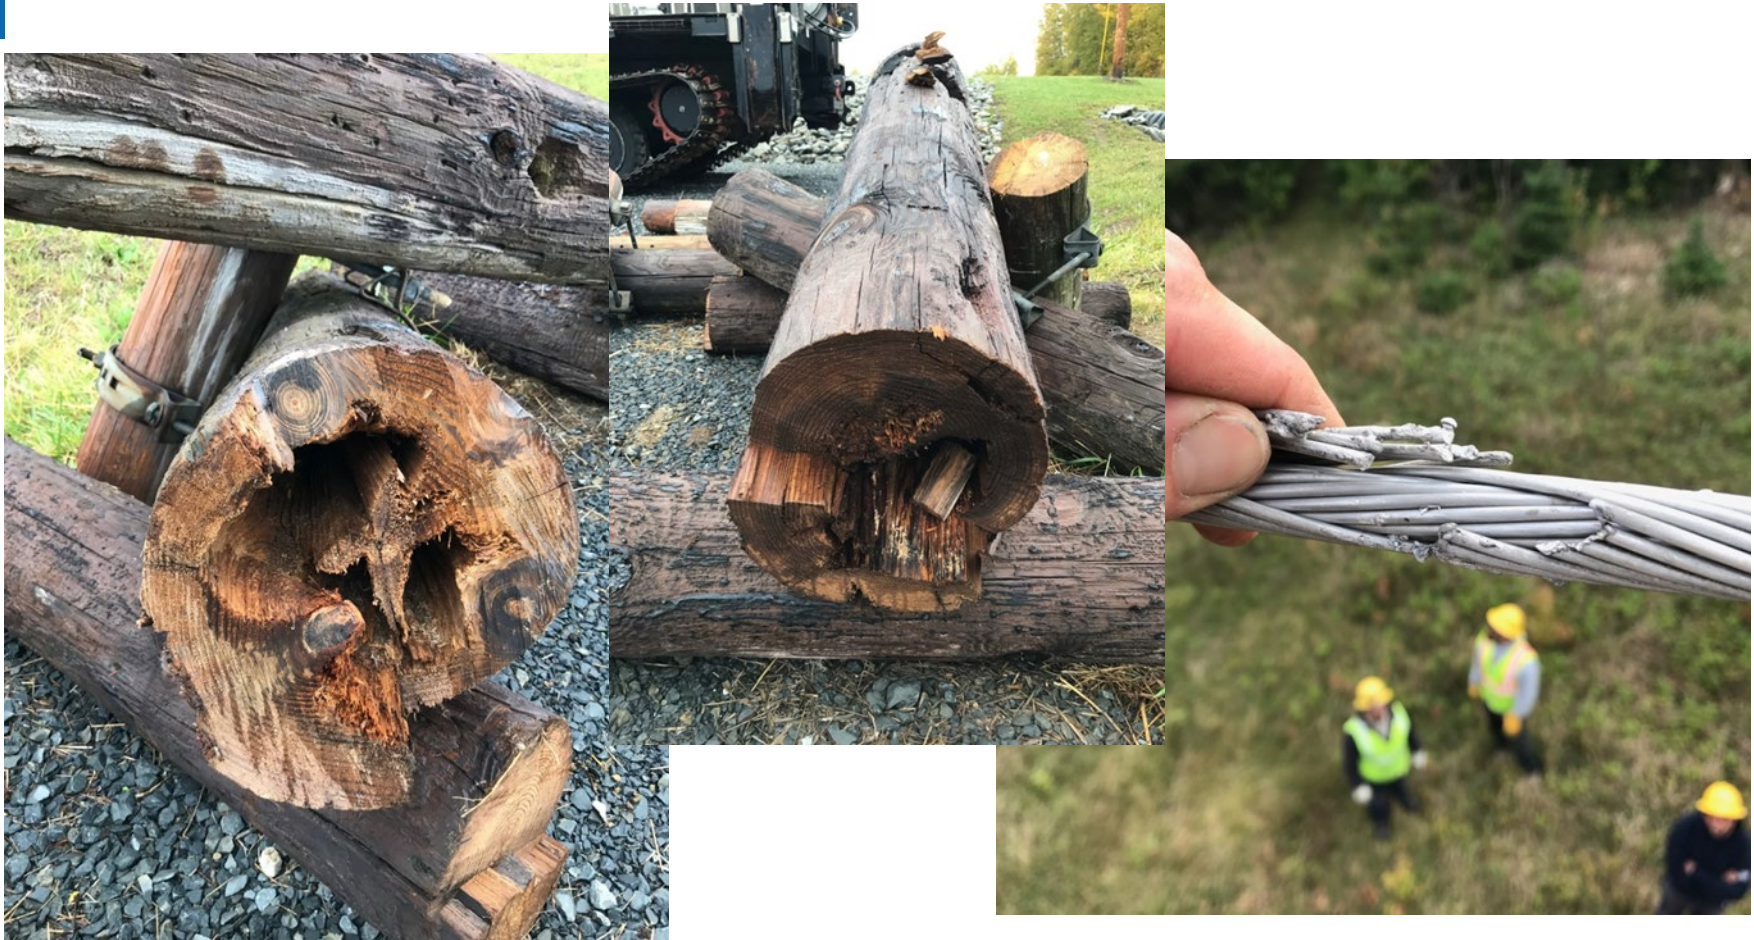
Line 1176 Rebuild per Inspection continued...

**Extensive internal rot due to fungus and woodpecker damage,
conductor damaged by contact with tree fall-in from outside ROW**

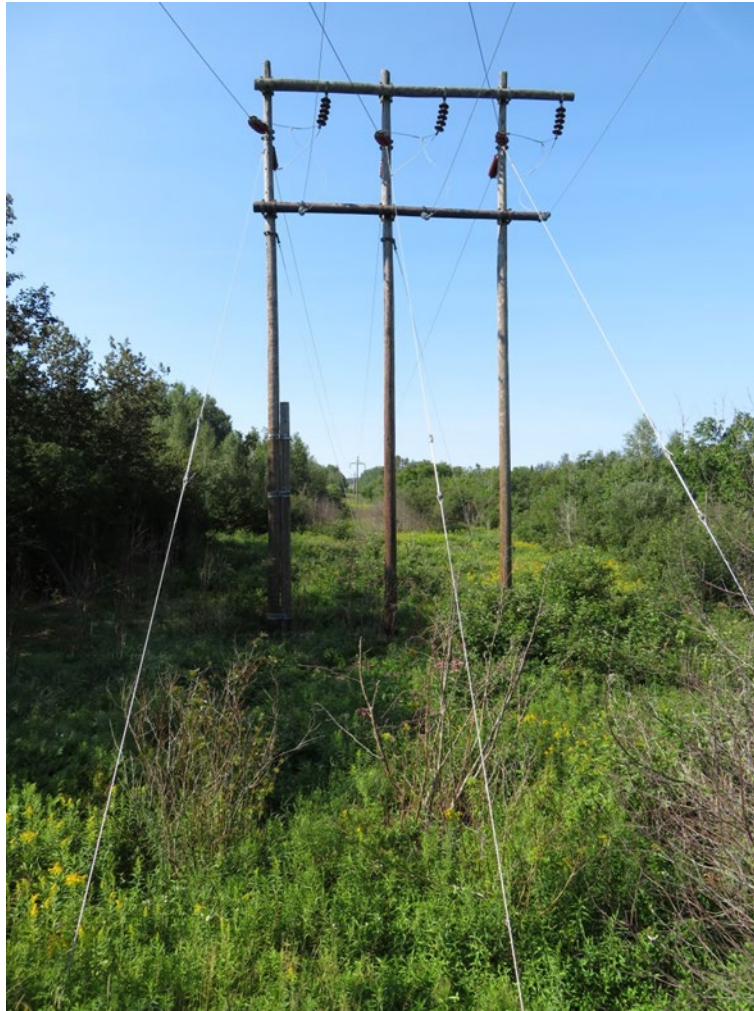
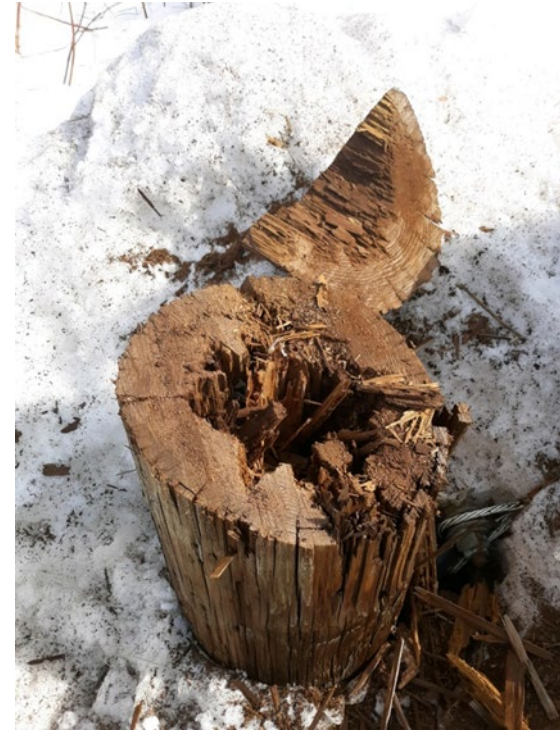
Line 6901 FF Tap continued...

Extremely poor condition three pole deadend structure, left pole previously stubbed to provide support for weakened pole, right pole rejected due to excessive internal decay.

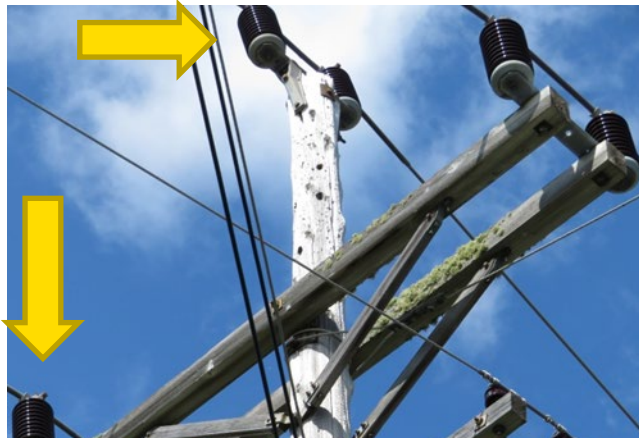
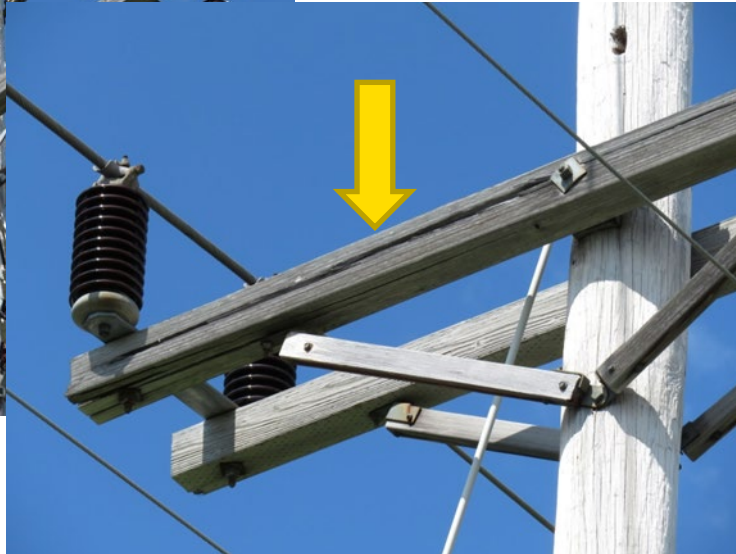
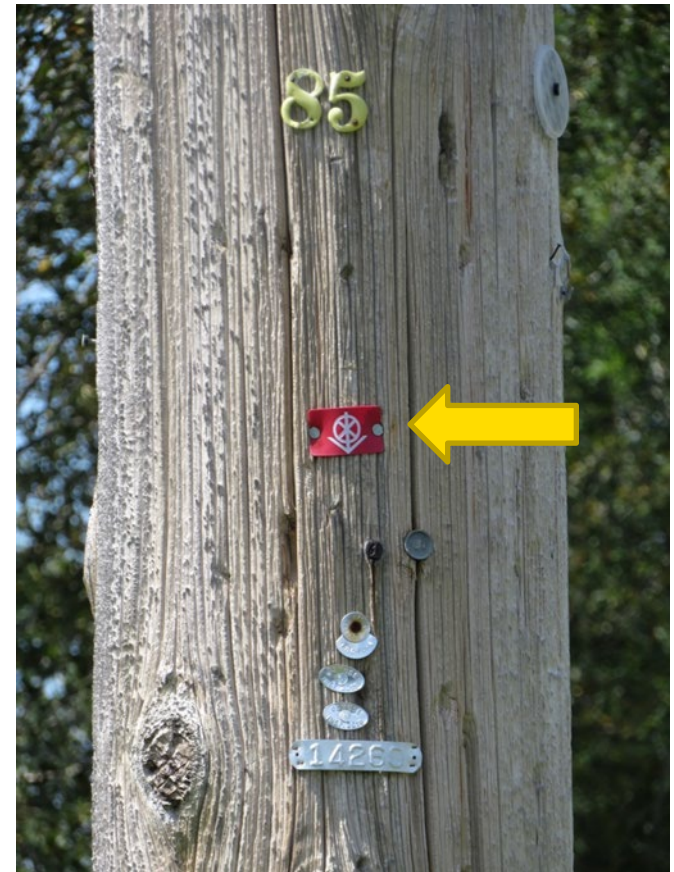
Line 6903 Rebuild (pole 57 to 127)

Brown glass post type insulators, cracked crossarms and rejected pole due to internal decay

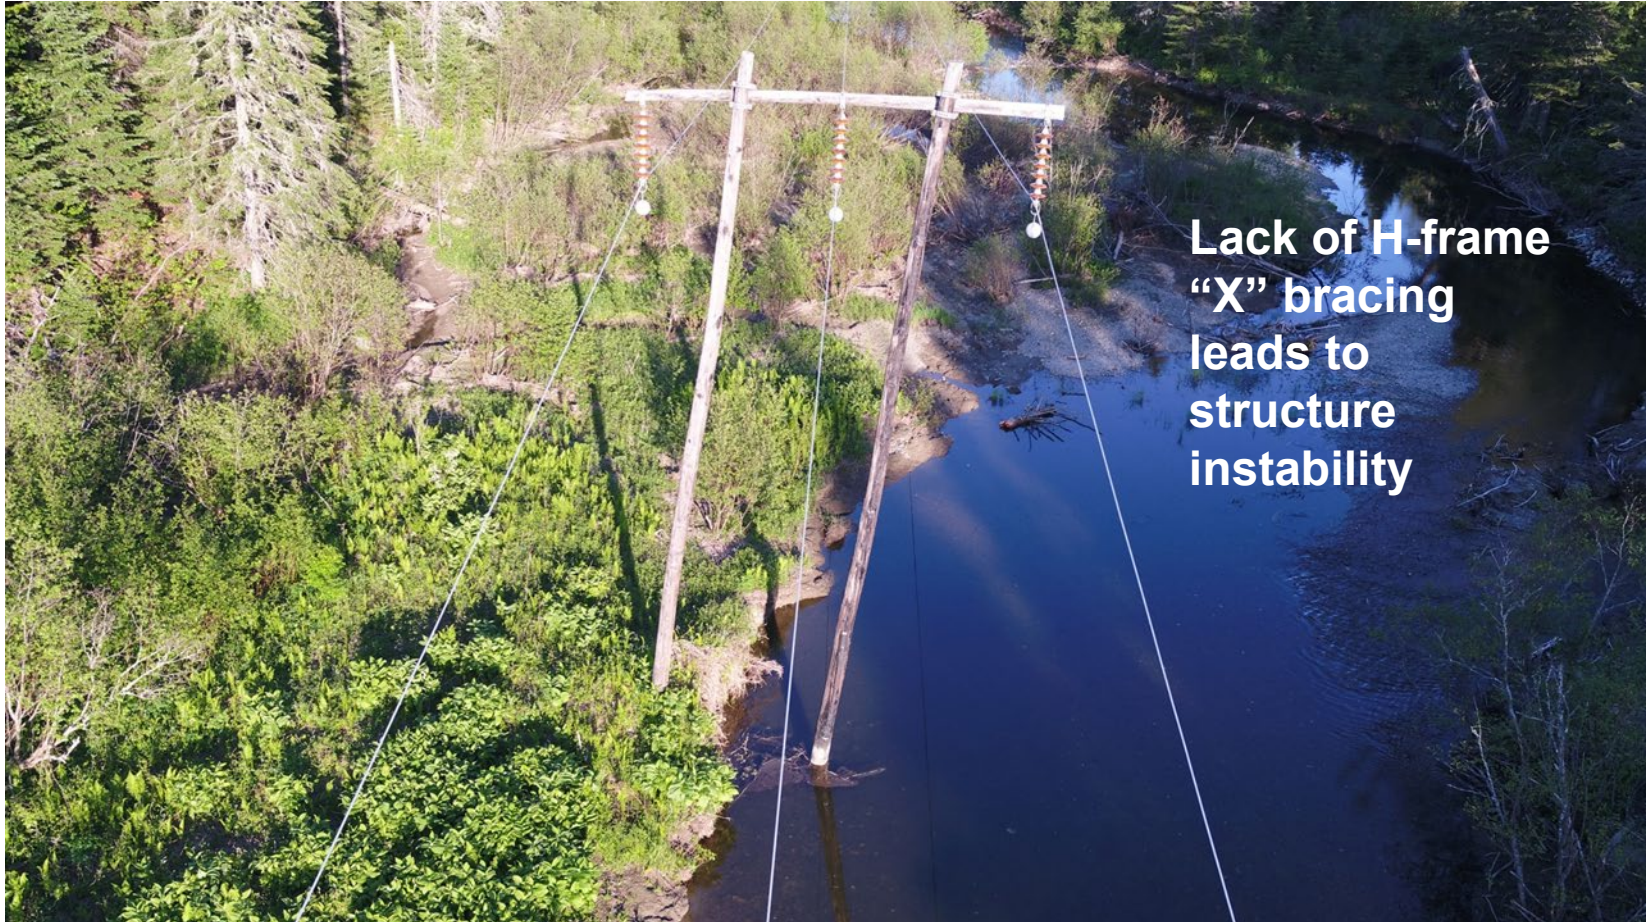
Line 1176 Rebuild continued...

Lack of H-frame
"X" bracing
leads to
structure
instability

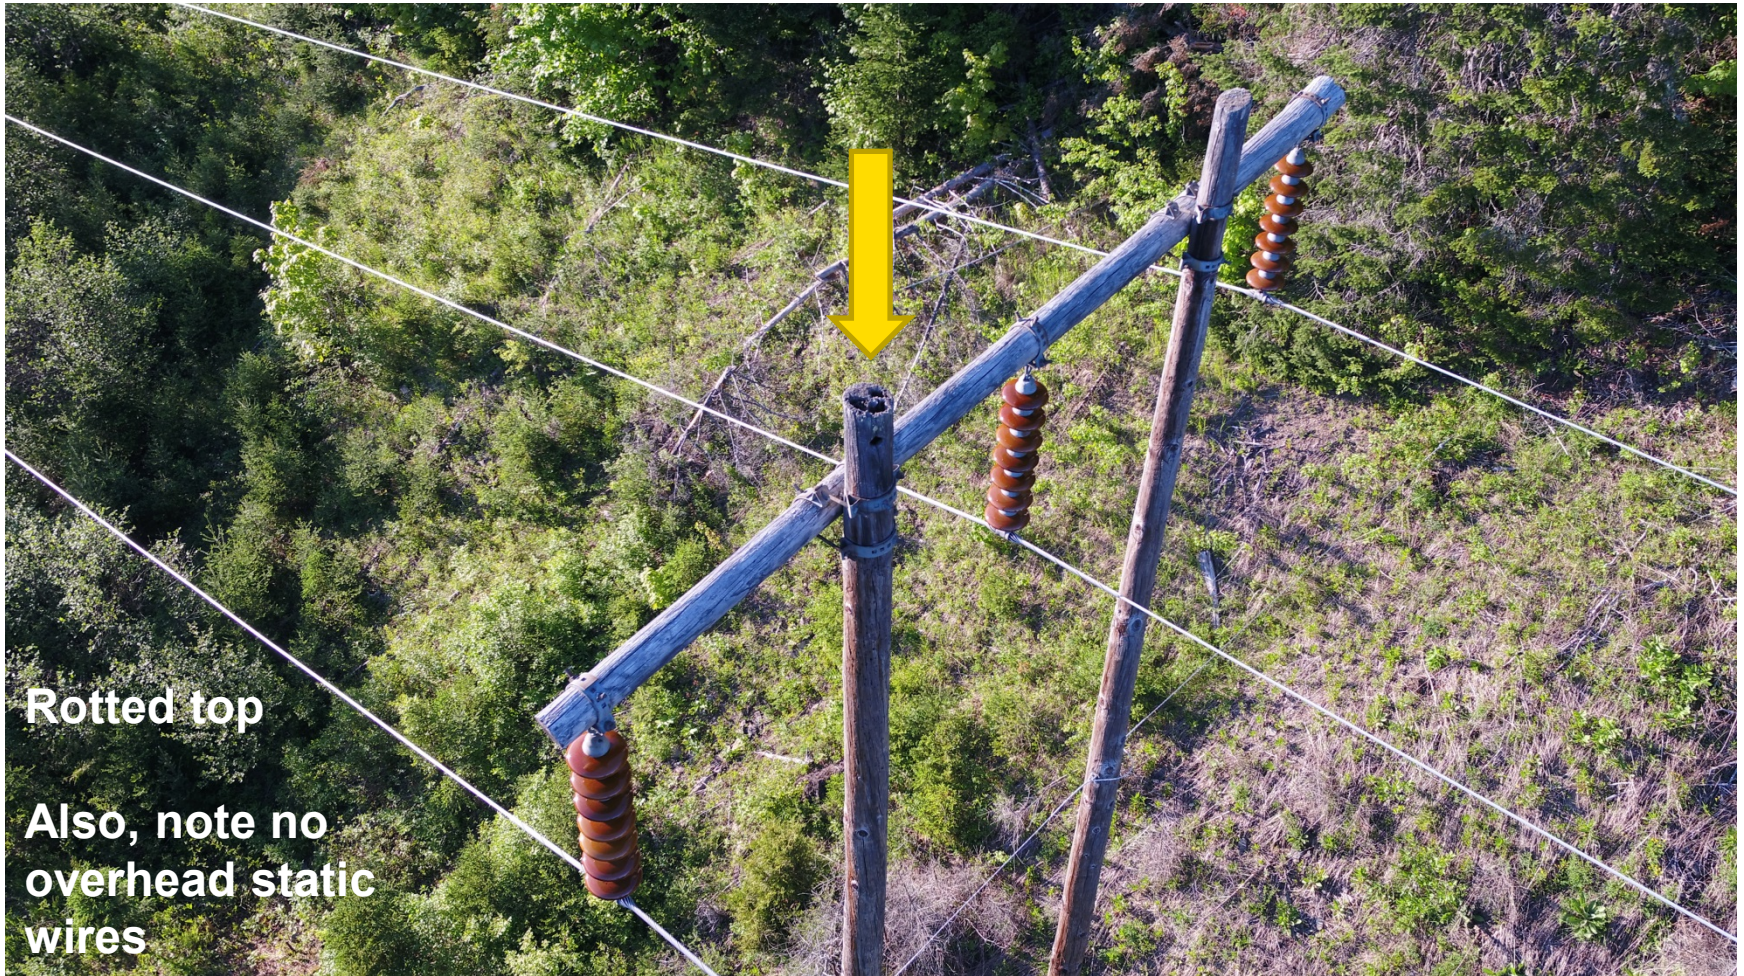
Line 1176 Phase 1 continued...

Rotted top

Also, note no
overhead static
wires

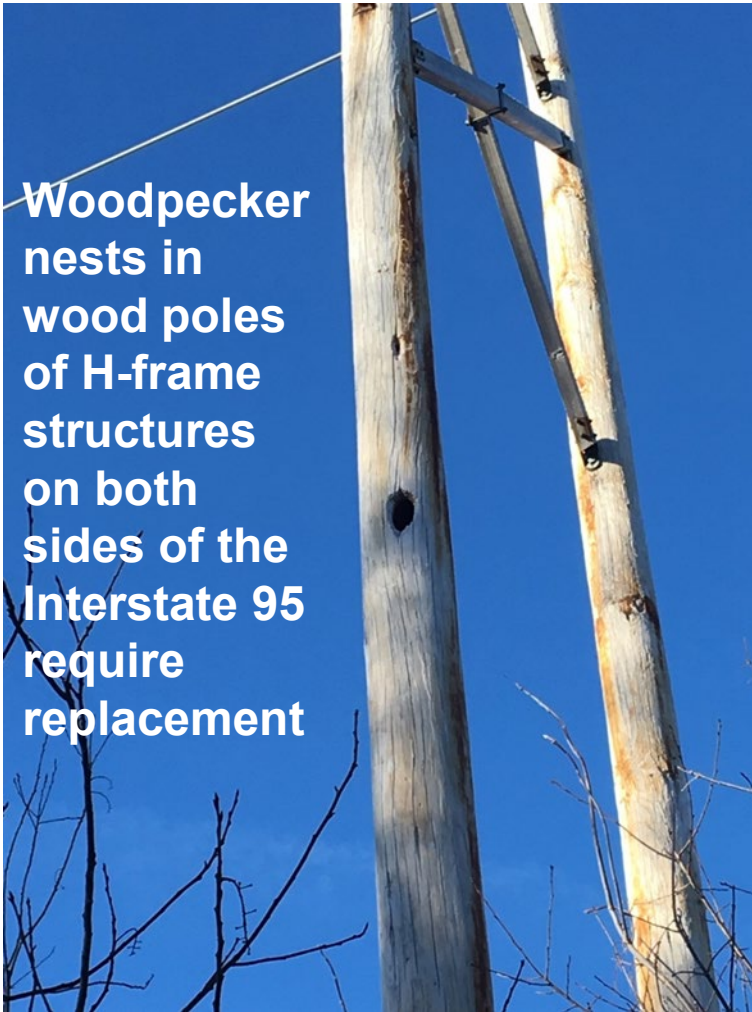
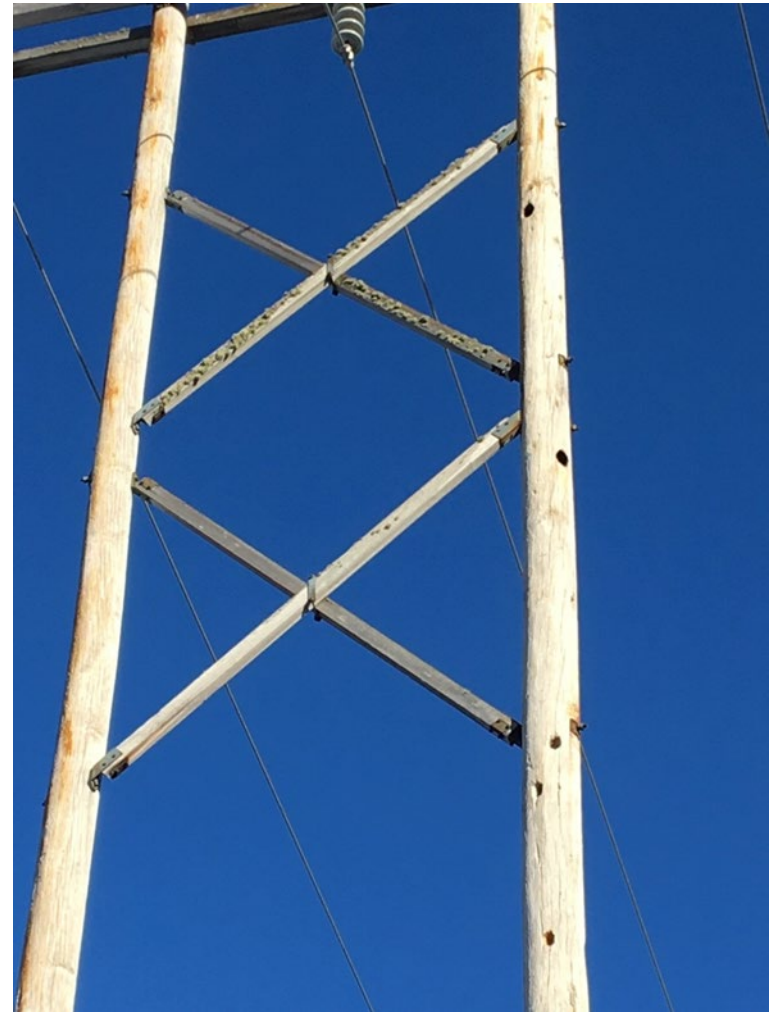
Line 4407 Interstate 95 Crossing

Woodpecker
nests in
wood poles
of H-frame
structures
on both
sides of the
Interstate 95
require
replacement

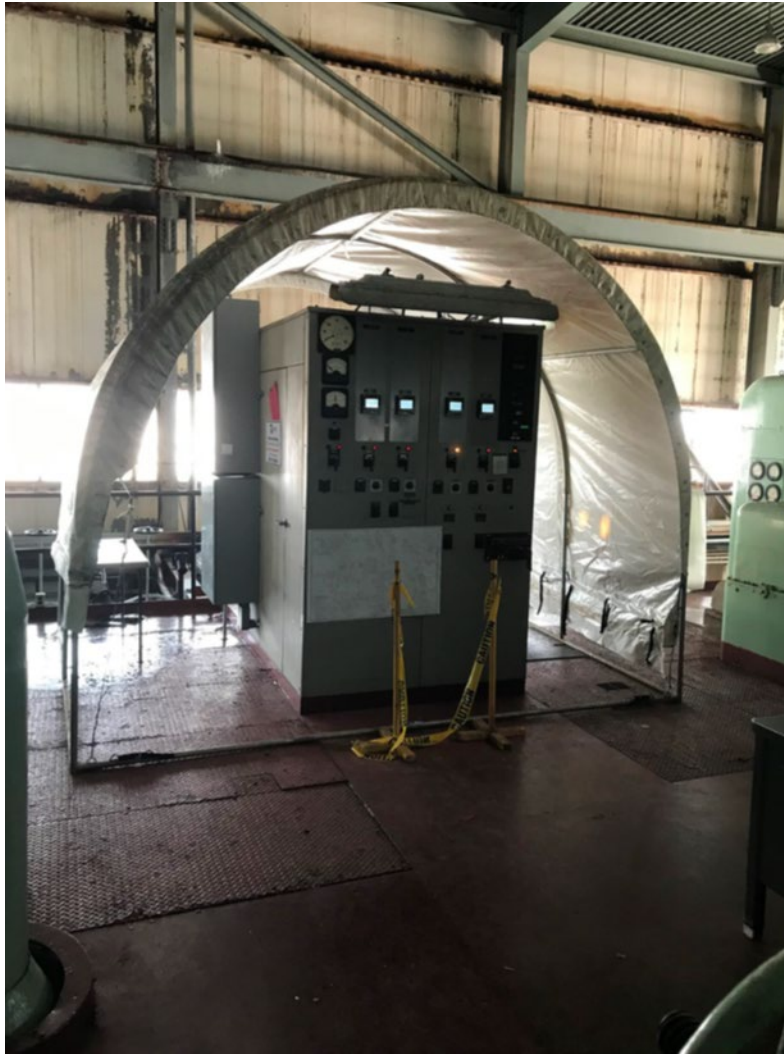
Caribou Switching Station

To protect its substation equipment from leaking water Emera Maine erected a tent as a temporary solution

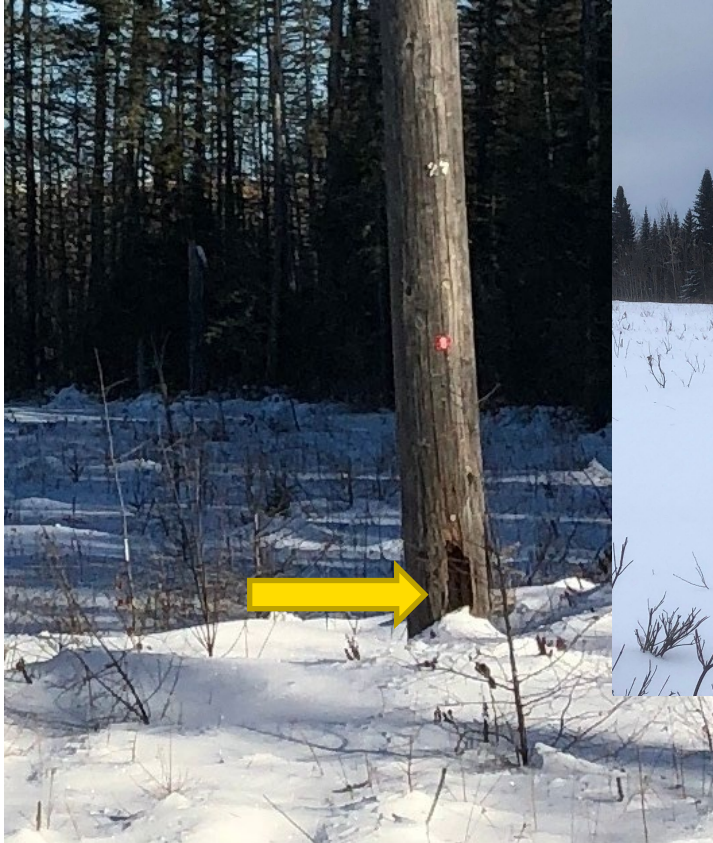
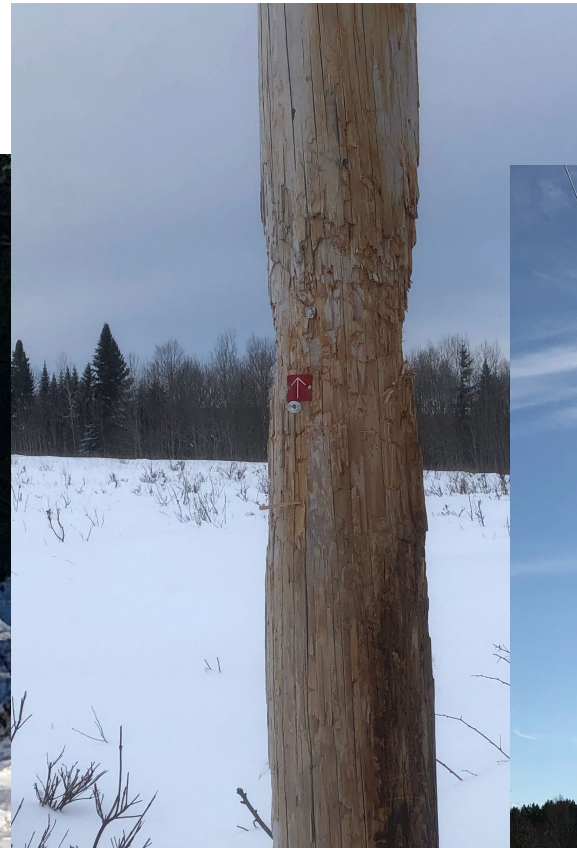
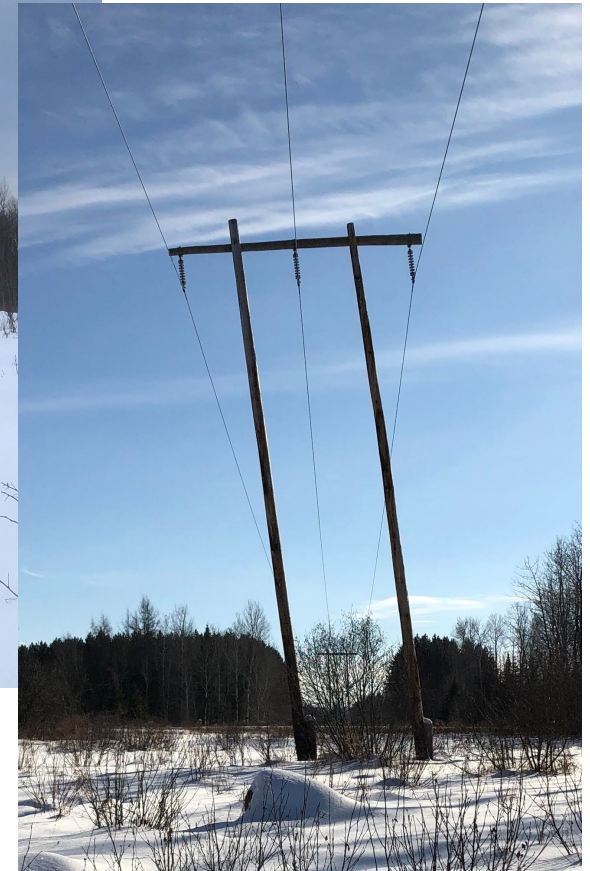
Line 6905

Rotted pole base, bear damage and leaning structure

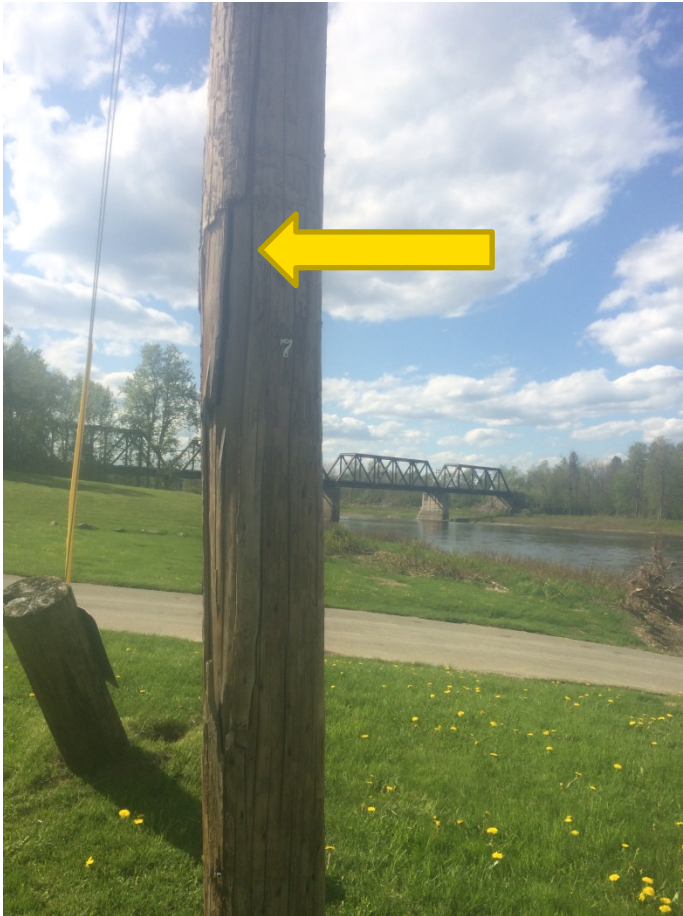
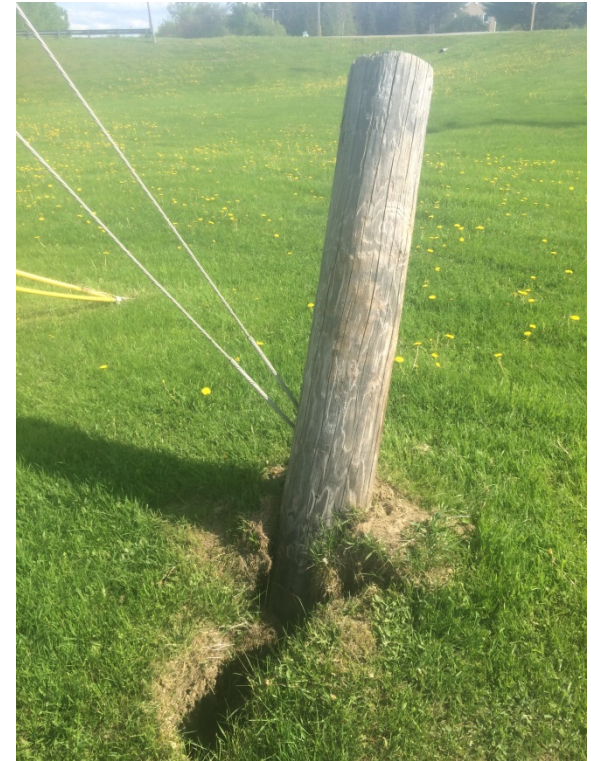
Line 6930 Washburn Ice Damage

Power of ice and water during 2019 spring flood of Aroostook River cracked a pole and pushed the wood pole guy guard backwards located at Castle Hill Road Boat Landing

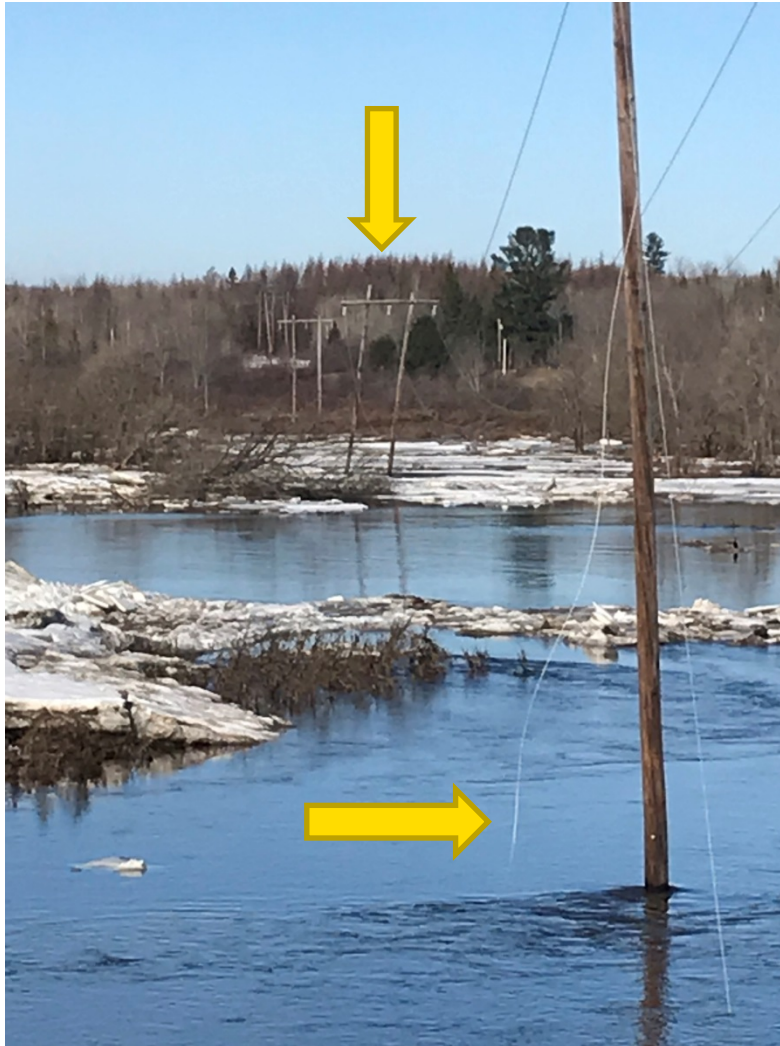
Line 6930 Washburn Ice Damage cont...

Wood pole H-frame structure excessive lean caused by spring flooding and contact with flowing ice that also broke guy wires on an additional structure. Access to this line segment is extremely difficult and at times impossible due to seasonal flooding, swampy wet ground and railroad tracks.

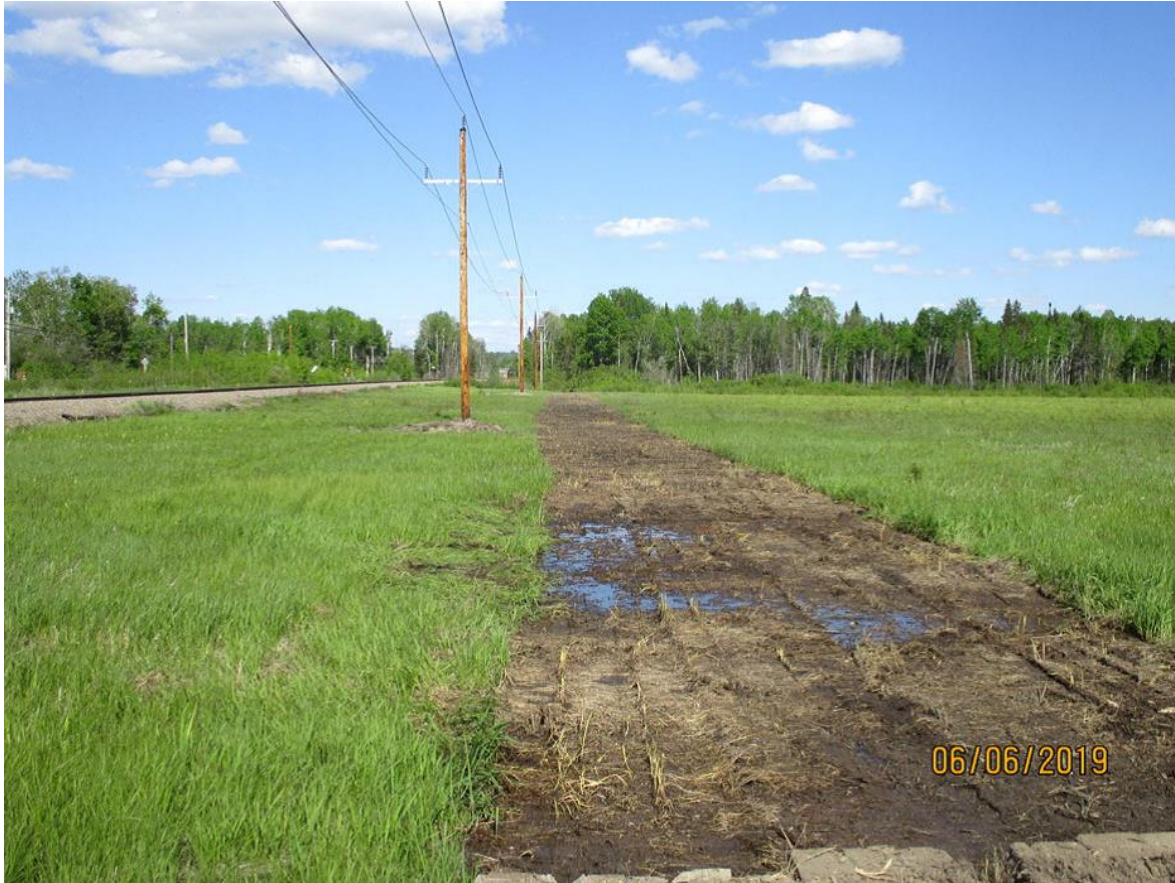
Line 6913 ROW

Winter construction required due to wet swampy ground. Horizontal "lower profile" configuration required by FAA due lines location at end of Presque Isle Airport runway

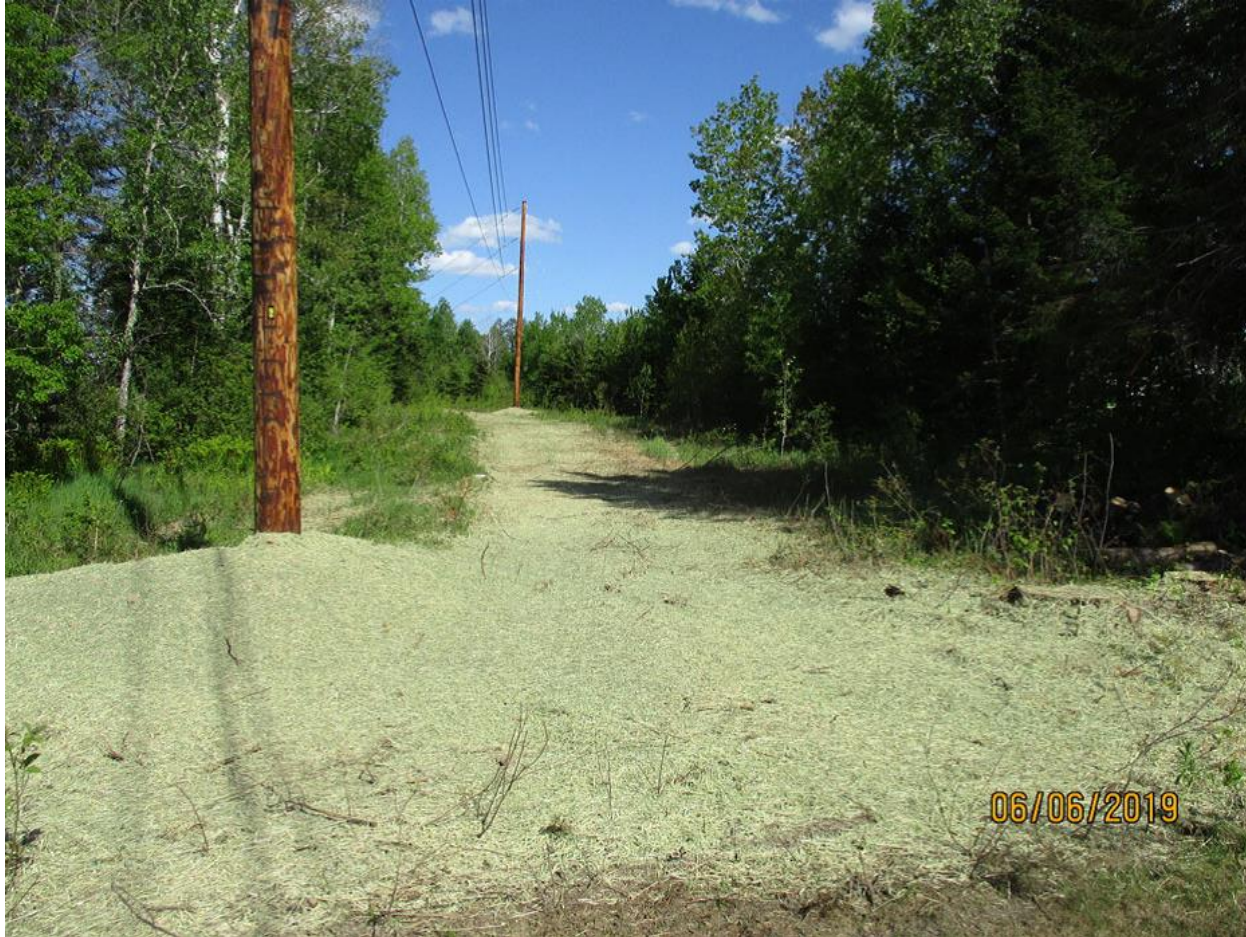
Line 6913 ROW continued...

Horizontal “flat” construction changed to vertical outside of FAA flight path zone
