June 17, 2021

2021 Planning Advisory Group Meeting

Northern Maine Transmission System

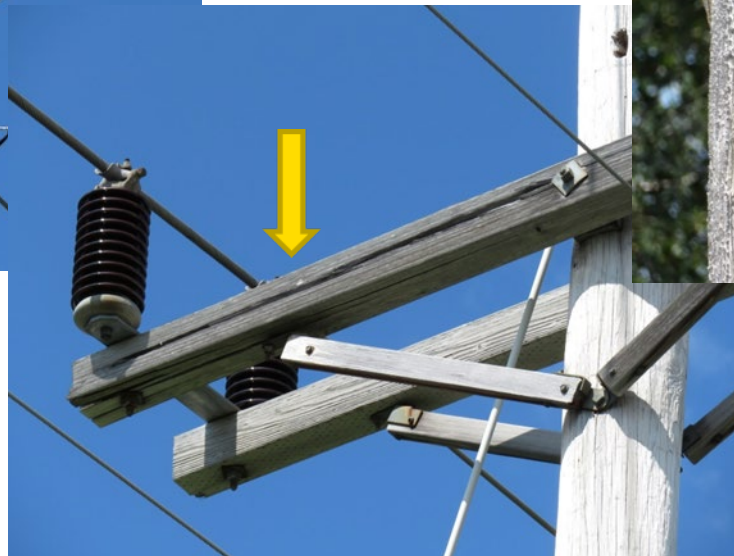
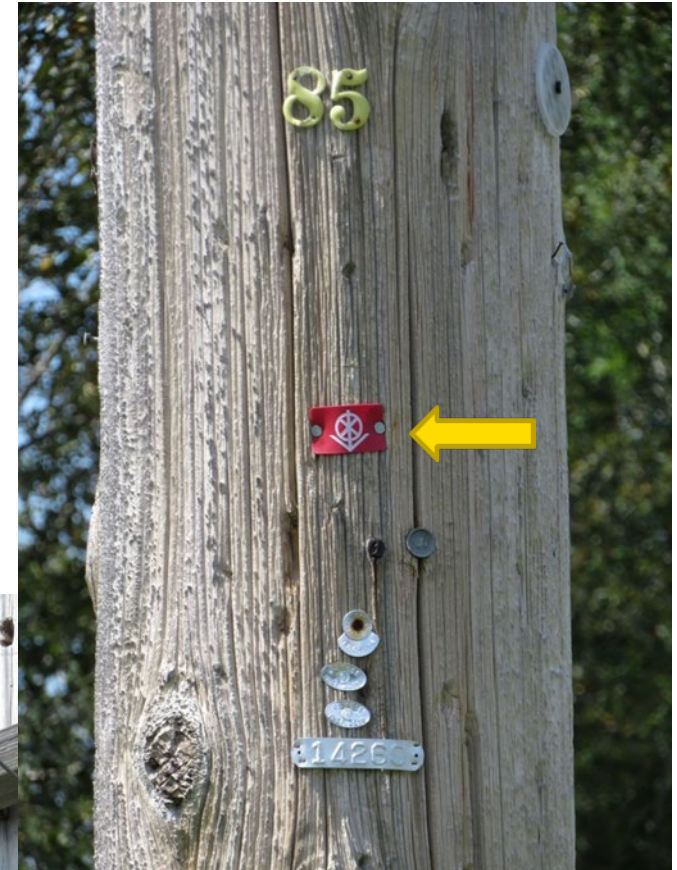
Line 6903 Rebuild (Caribou & Limestone)

Brown glass post type insulators, cracked crossarms and rejected pole due to internal decay

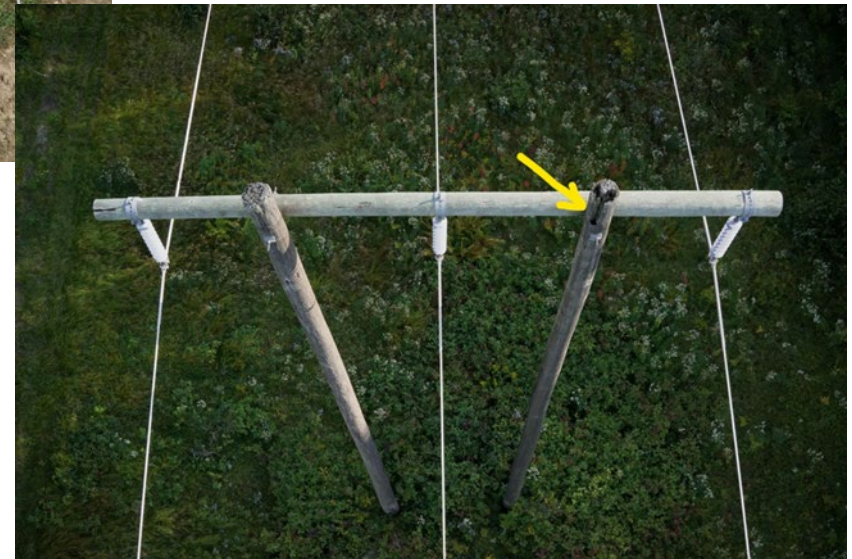
Line 6905 Emergency Pole Replacements

Excessive pole and crossarm rot detected by UAS (a.k.a. drone) inspection resulted in an emergency structure replacement project

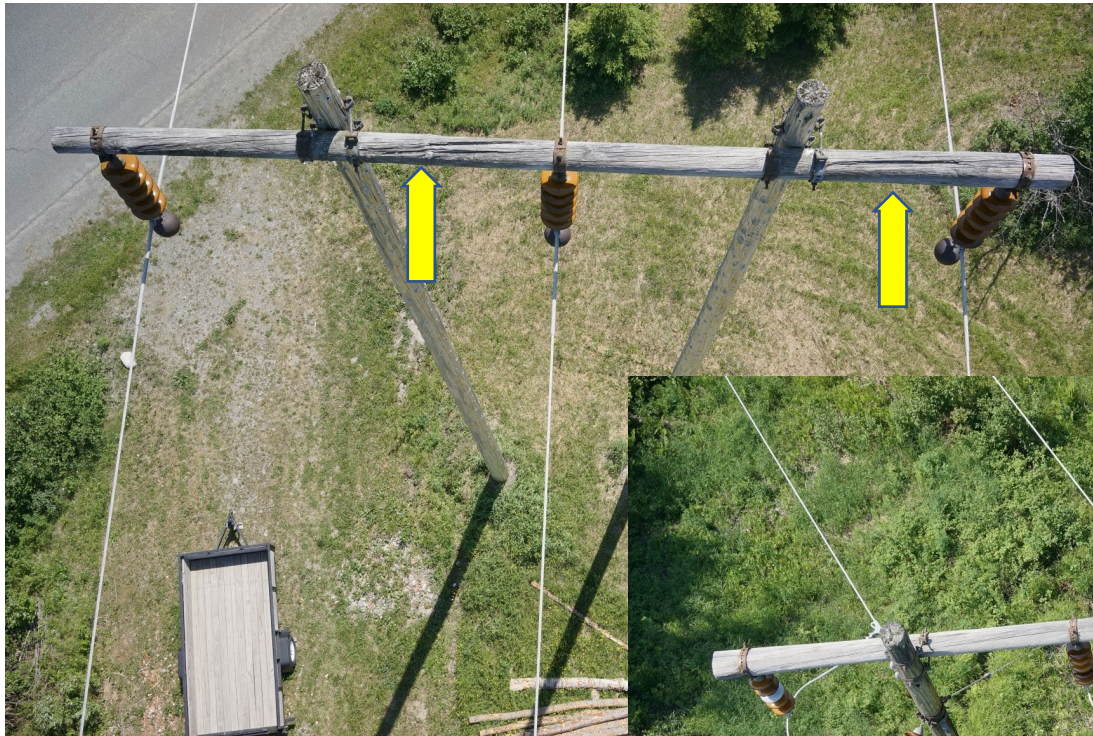
Line 6909 Condition Continued...

Line 6909 built in 1961, comprised of 160 wood pole structures.

13% rejected in 2019 due to insufficient shell thickness, this quantity will continue to climb as this line ages

Rotting wood pole crossarms and pole tops

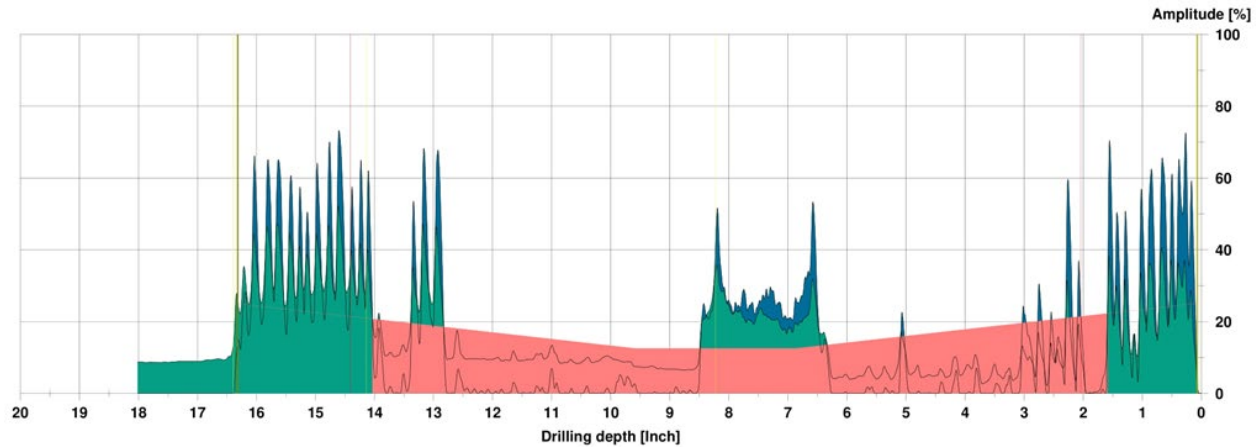
Rejected Wood Pole – Heart Rot & Shell Rot

Program :	Pole - EMERA 1.00	Sum decay :	2,9%	0,0%	2,9%
Pole type :		Heart rot :	2,9%	0,0%	2,9%
Measurement :	Below soil level	Shell rot :	No	Yes	
Defect pattern:	Heart+shell rot	Remaining wall:	21,7%	---	
Result (auto) :	REJECT	Strength :	89,7%	---
