June 17, 2021

2021 Planning Advisory Group Meeting

Northern Maine Transmission System

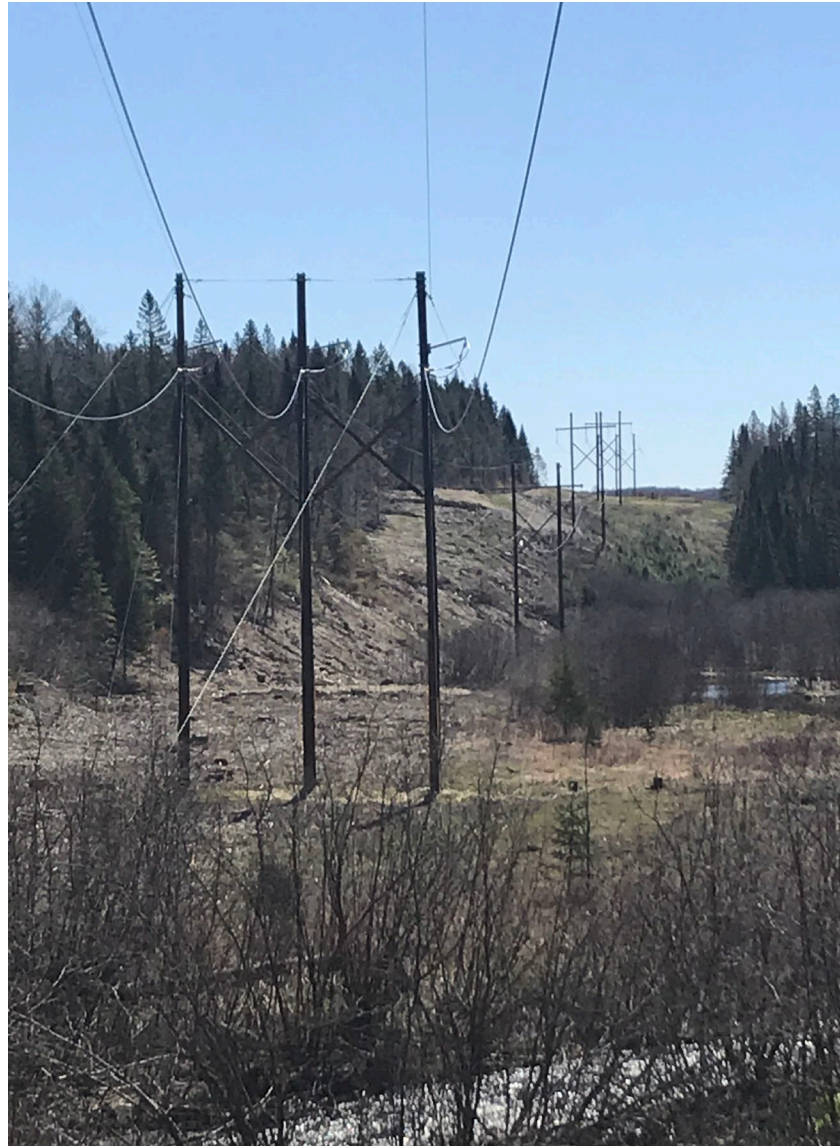
Line 1176 Rebuild Phase 1&2 – New Line

Bank of H-frame
bracing leads
structure
stability

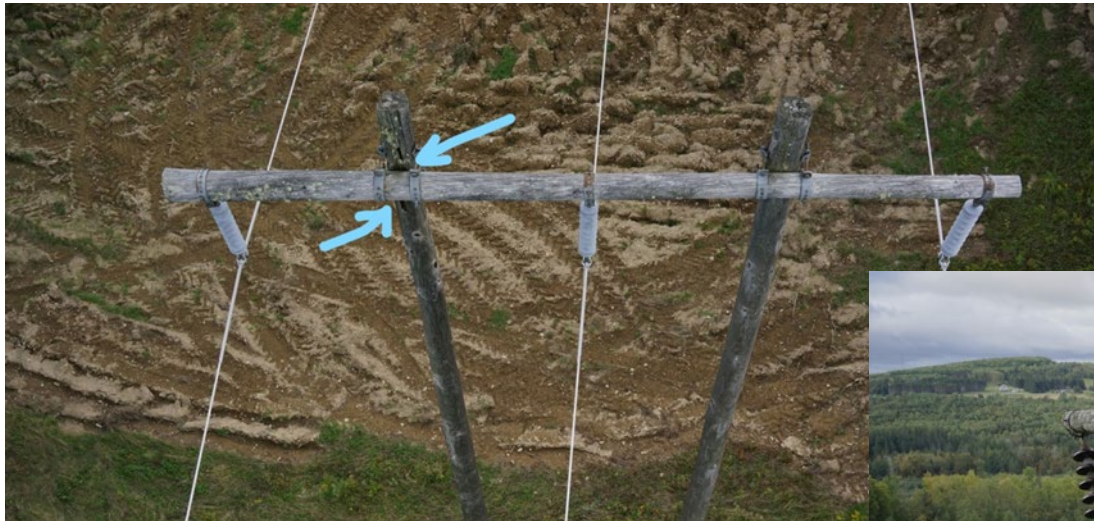
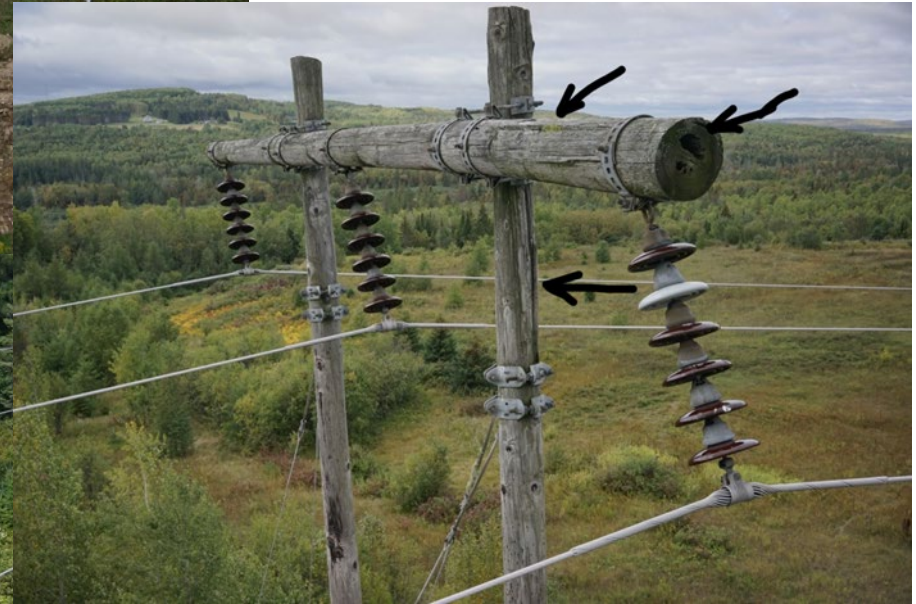
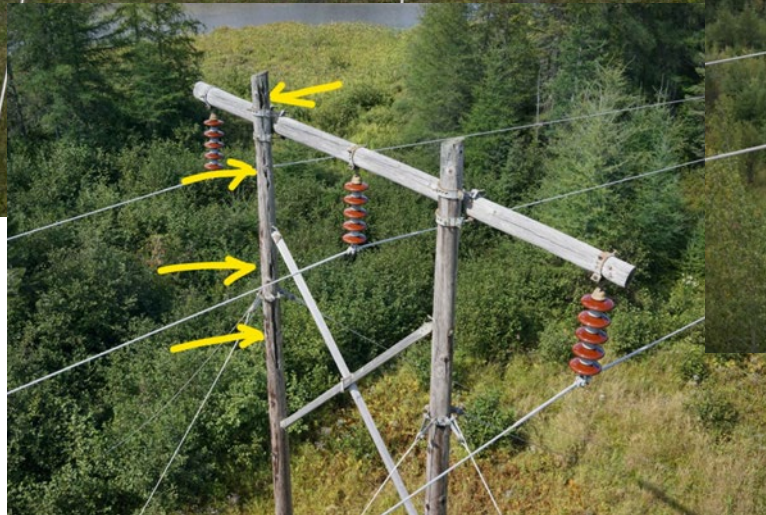
Line 6905 Condition continued...

Excessive pole and crossarm rot detected by UAS (a.k.a. drone) inspection resulted in an emergency structure replacement project

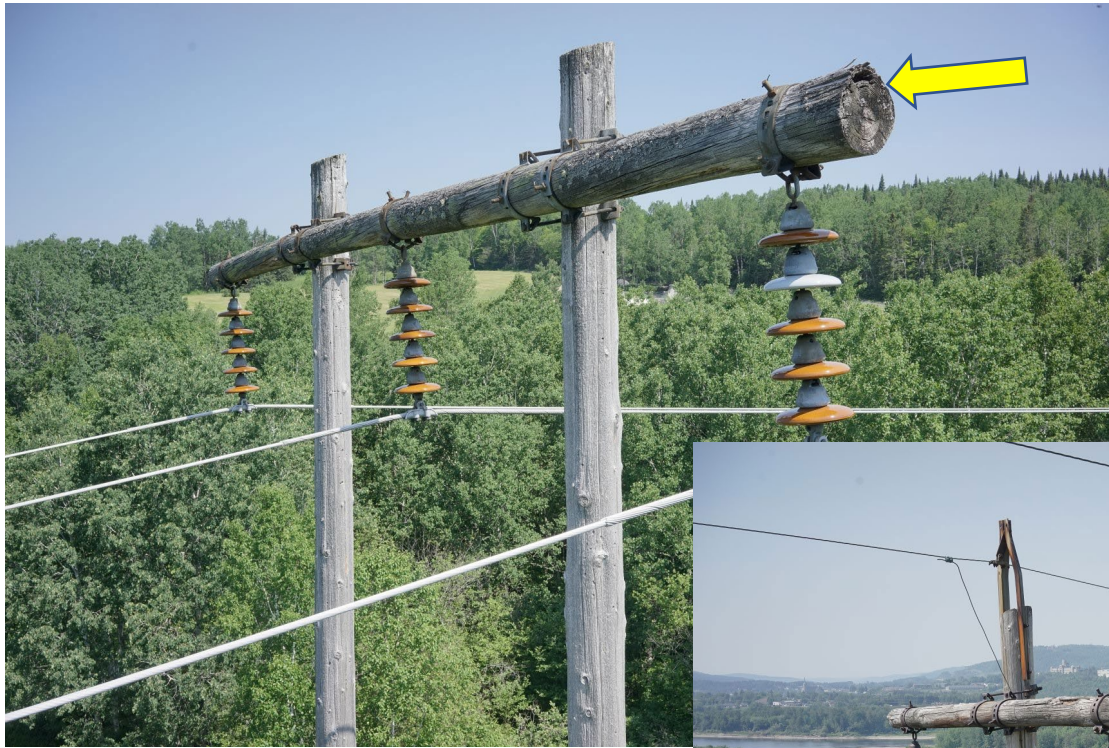
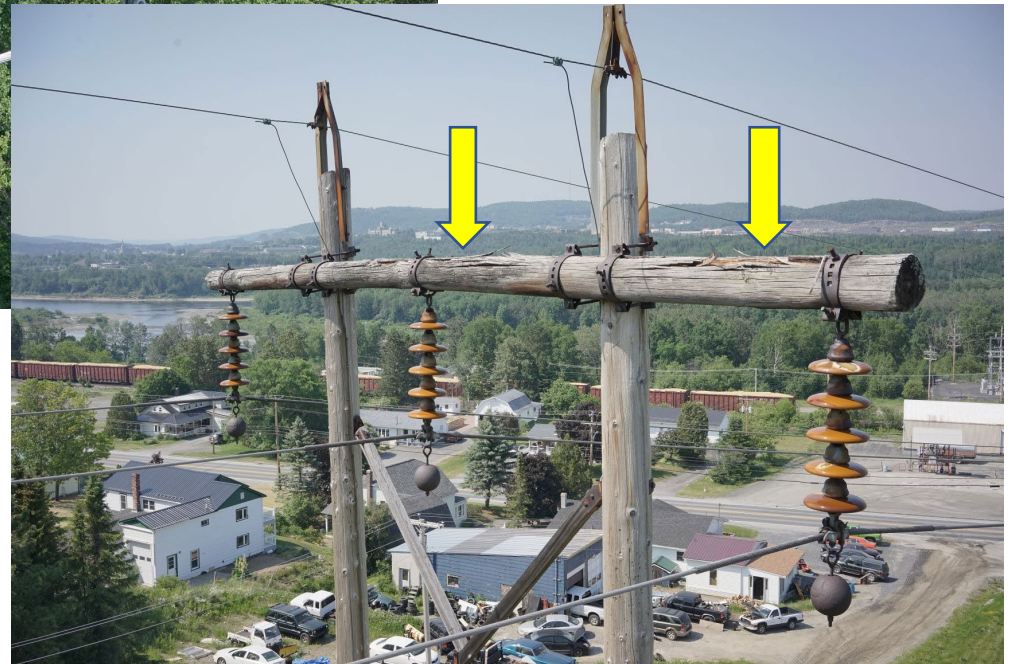
Line 6909 Condition Continued...

13% rejected in 2019 due to insufficient shell thickness, this quantity will continue to climb as this line ages

Rotting wood pole crossarms and pole tops

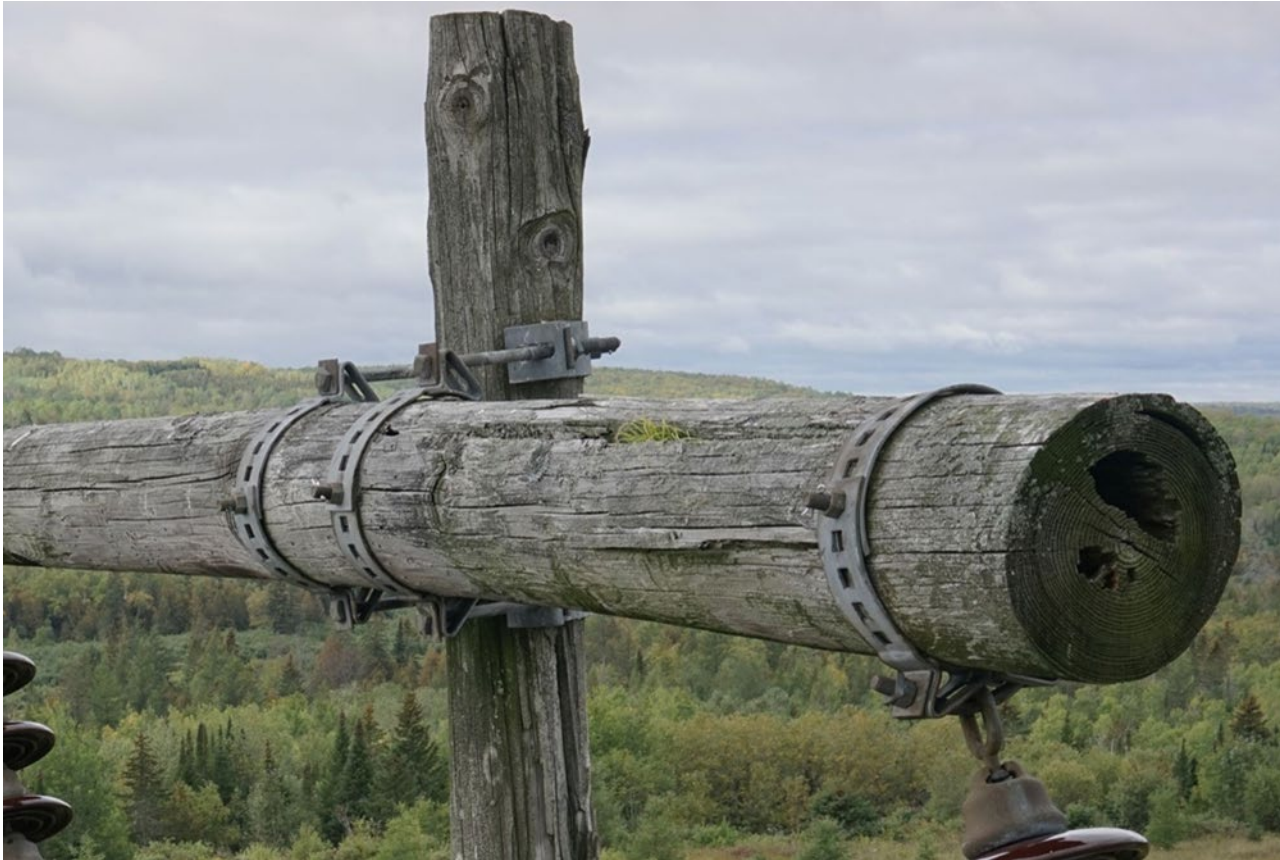
Example of a Closeup Drone Inspection Photo
