June 24, 2024

# 2024 Chapter 330 Report

# Northern Maine Transmission System Chapter 330 Work Plan Map

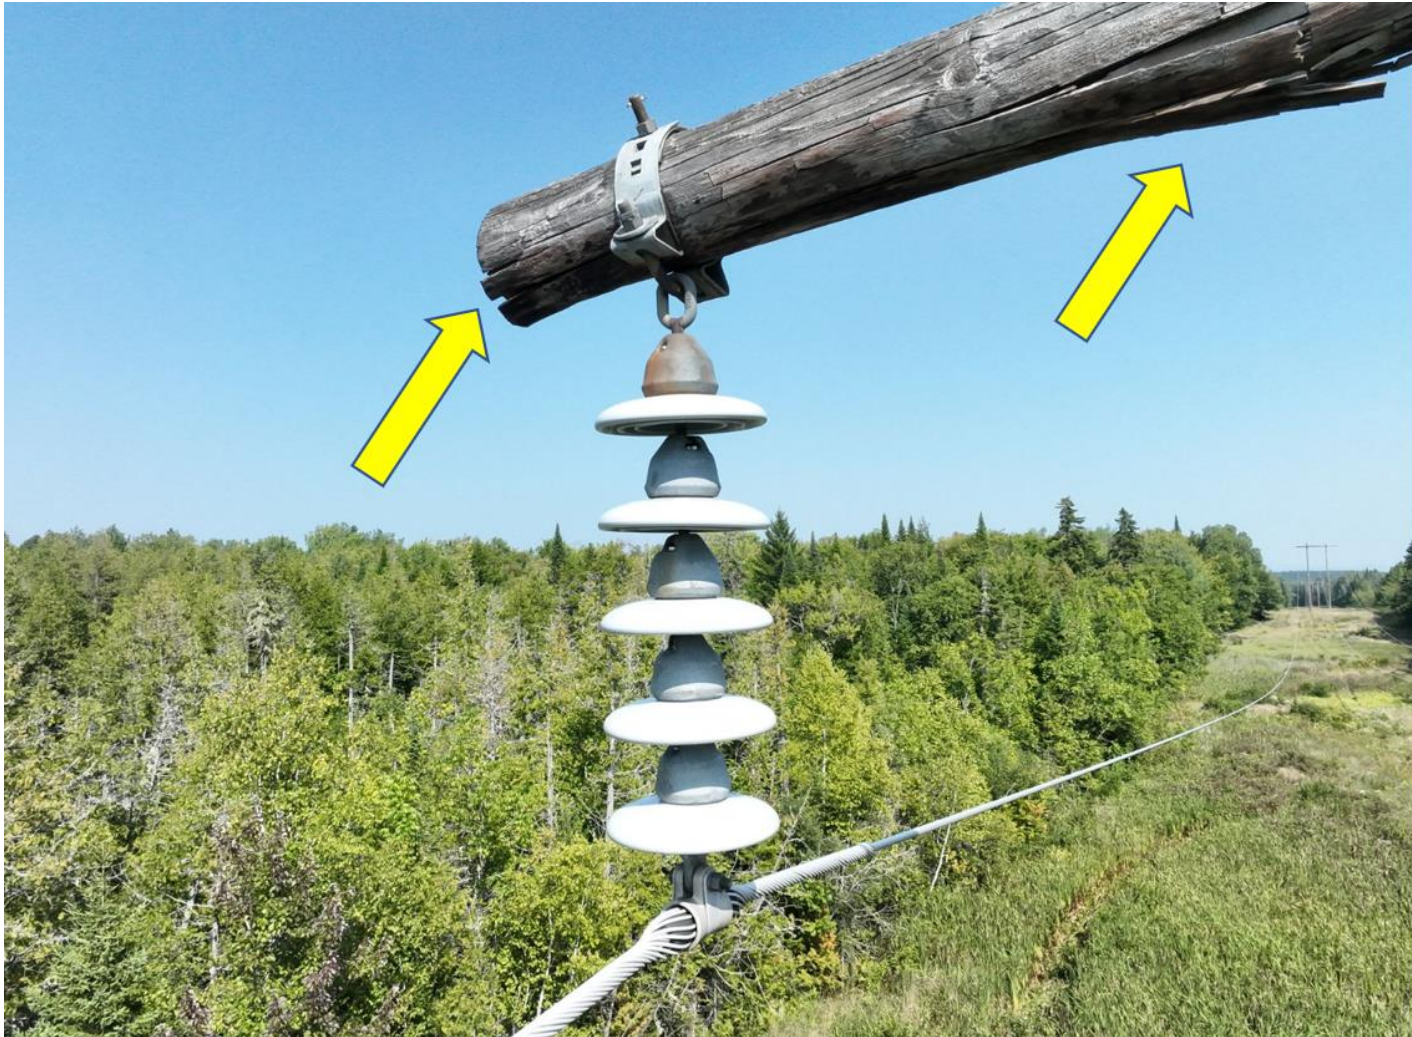
# Line 6930 Condition continued...

- **Line 6930 – Line connects Caribou Substation to Ashland Substation with a tap serving the Washburn community. The line is 34 miles long, with 133 structures, 20% of structures have been replaced. The most recent drone inspection indicates 9 rejected poles, 94 have moderate decay, 24 low decay. TRPI in 2024 to replace 24 poles. Further TRPI work is likely in the near future.**
